OLD EXECUTIVE OFFICE BUILDING

BUILDING CONDITION REPORT

PREPARED FOR
THE GENERAL SERVICES ADMINISTRATION
NATIONAL CAPITOL REGION
WASHINGTON, D.C.

JUNE 6, 1990

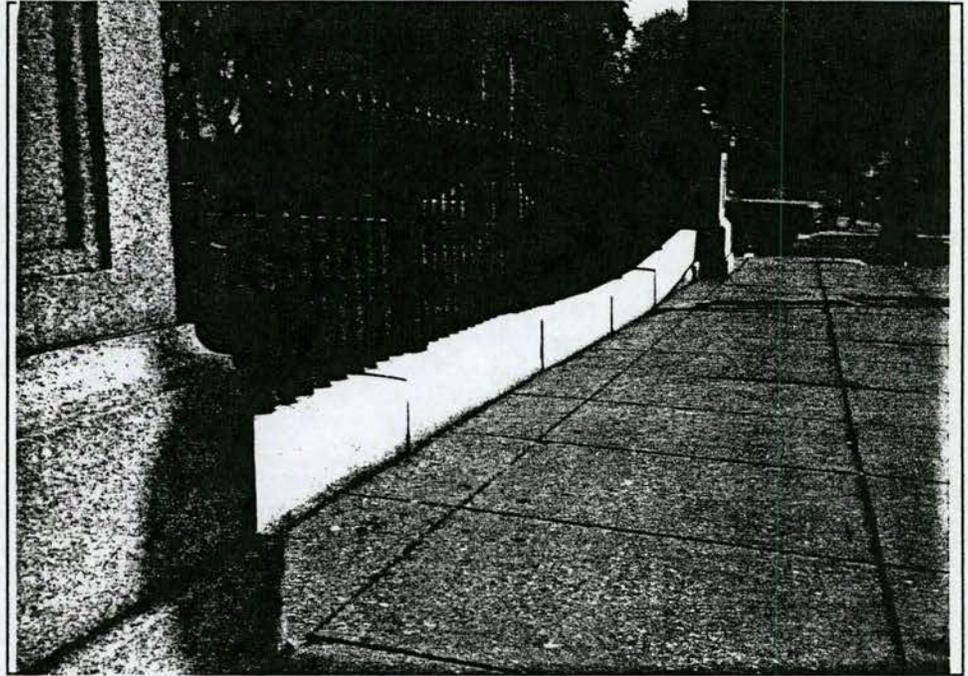
Photo 1

Severely settled retaining wall along
h Street at southwest corner of
site. To be repaired under Exterior
and Miscellaneous Repairs project.

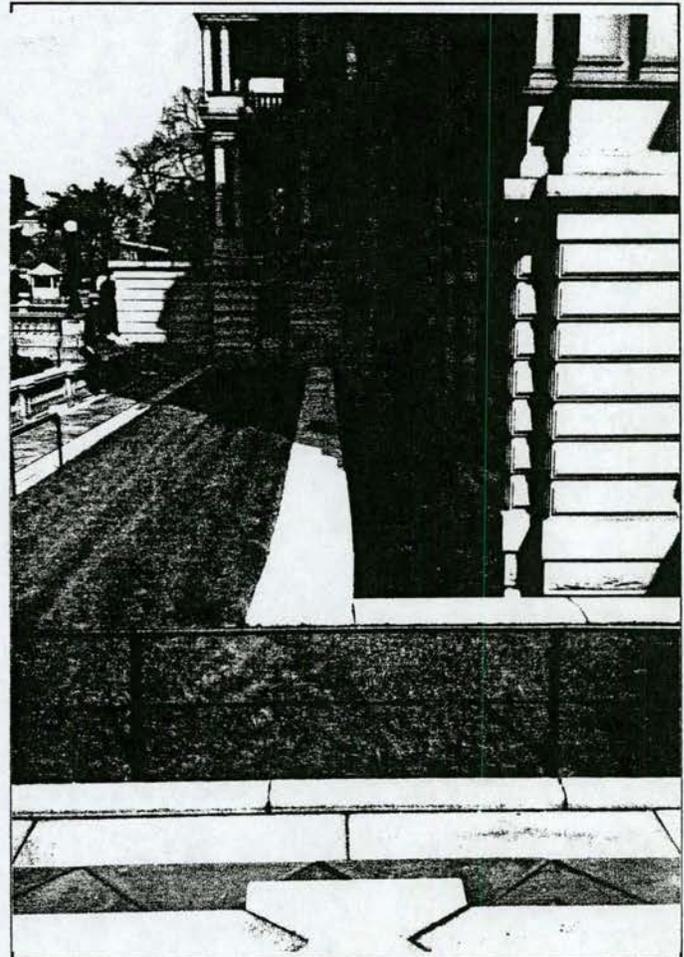
Photo 2

Differential movement in moat retaining wall at the northwest
corner of the building. This problem to be addressed by the
Exterior and Miscellaneous Repairs project. Recommended
long-term monitoring to evaluate any future movement.

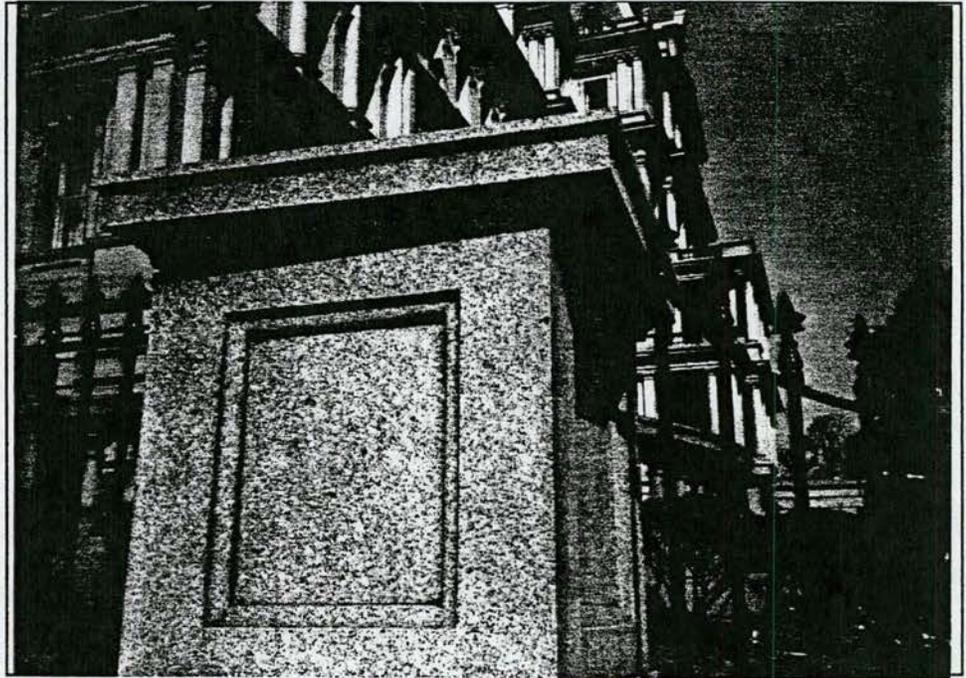
Photo 3
Displaced granite pier cap along 17th
Street. To be repaired under the
exteriors' project.

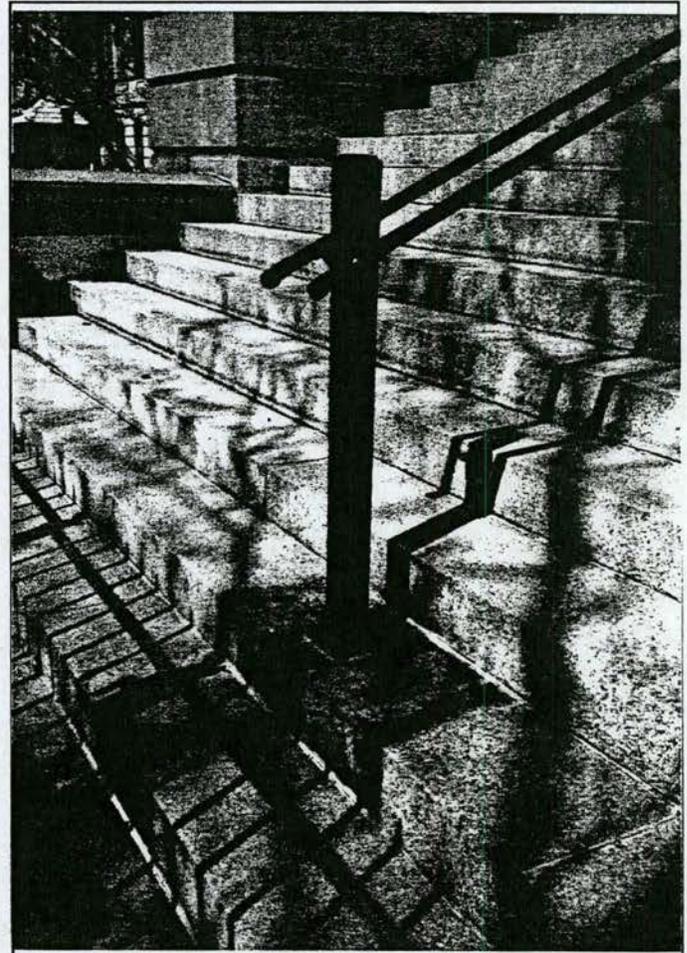
Photo 4
Severely rust-stained granite stair along 17th Street.

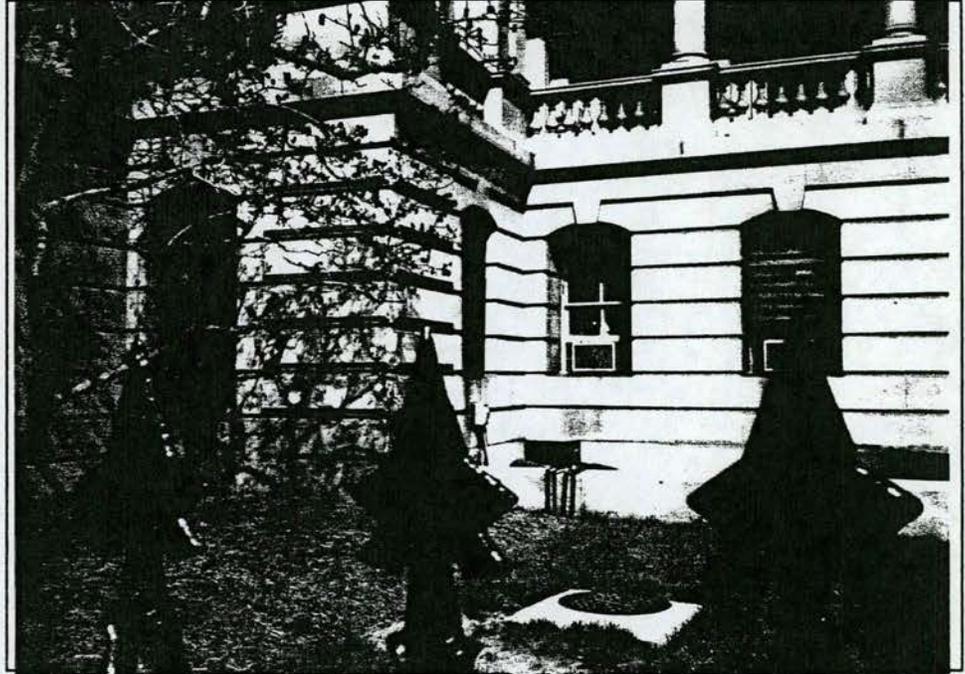
Photo 5

View from 17th Street showing multiple window modifications. From the left: two retained security screens; air conditioner set in open window; and partially louvered window with air conditioner. Note stains beneath center air conditioner.

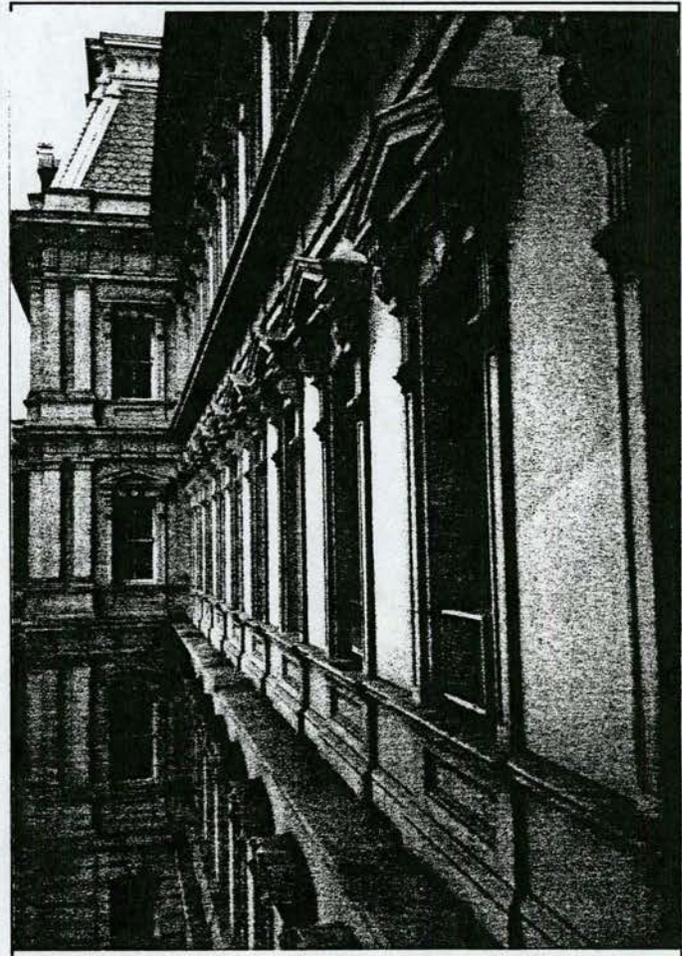
Photo 6

West elevation showing inserted window air conditioners and resulting mineral stains from condensed water from AC units.

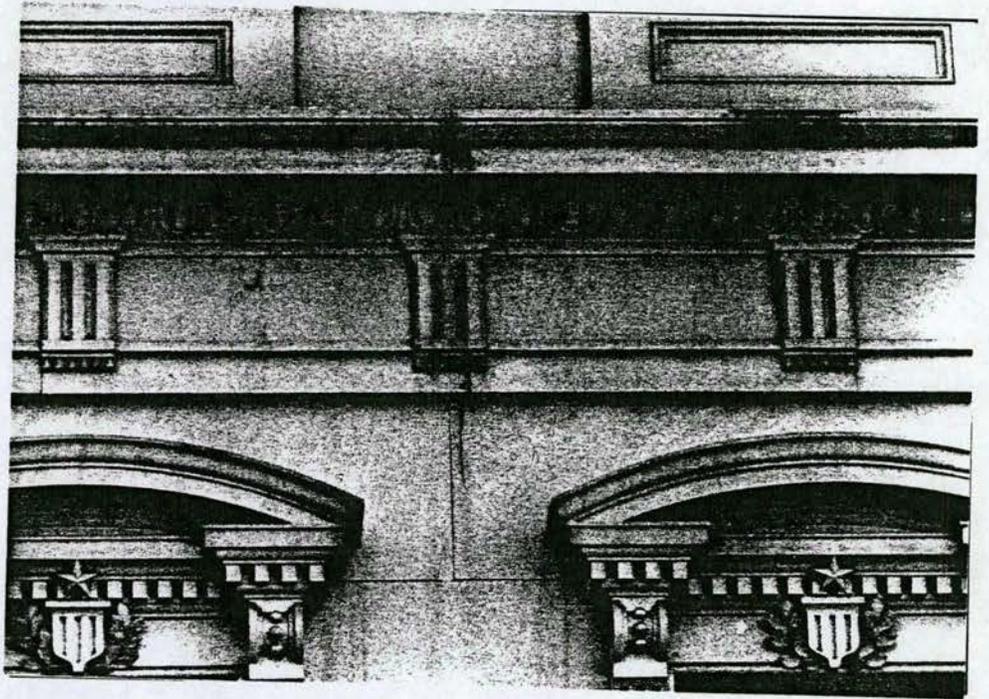
Photo 15

Note structural failure of individual granite block. Location of crack corresponds to joints in stone courses above and below. Note also that vertical joint is open above metope.

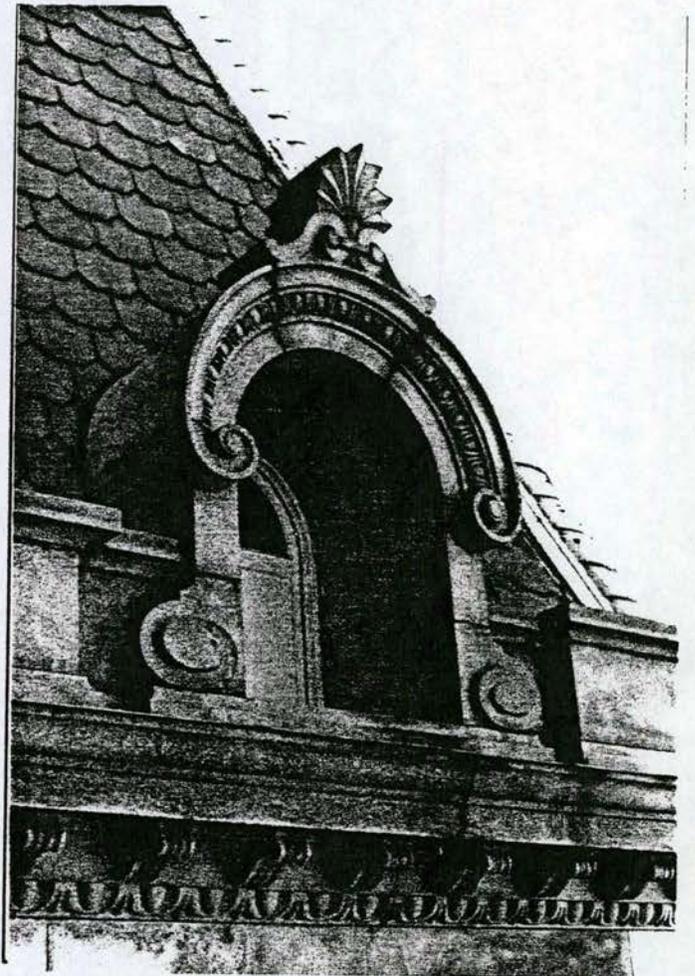
Photo 16

Note staining of the face of granite blocks at window arch adjacent to open vertical mortar joint.

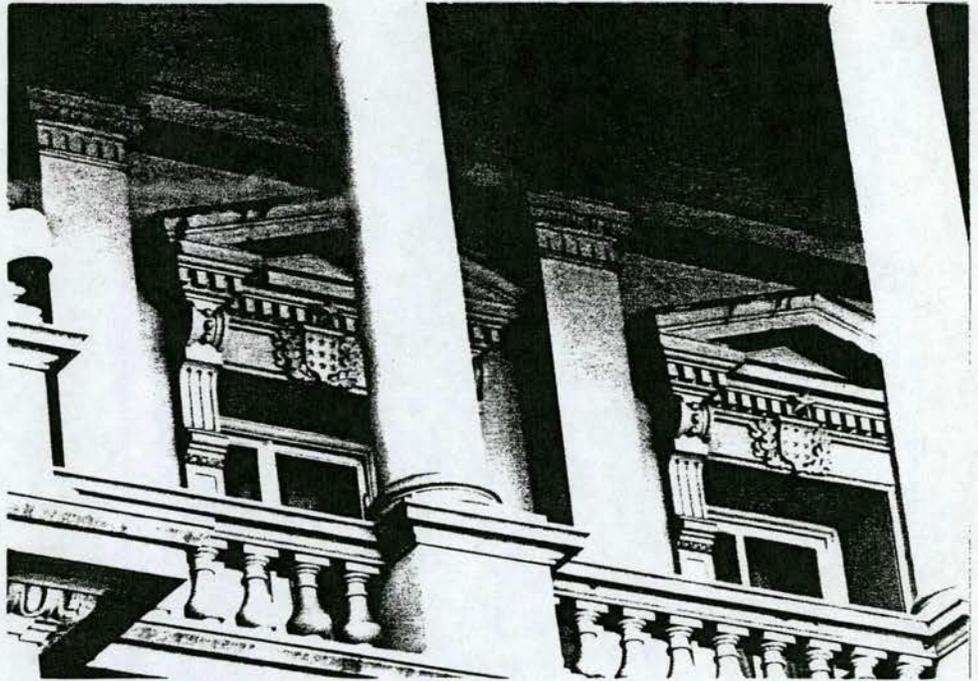
Photo 17 Note staining of the face of granite due to inappropriate methods of pigeon control.

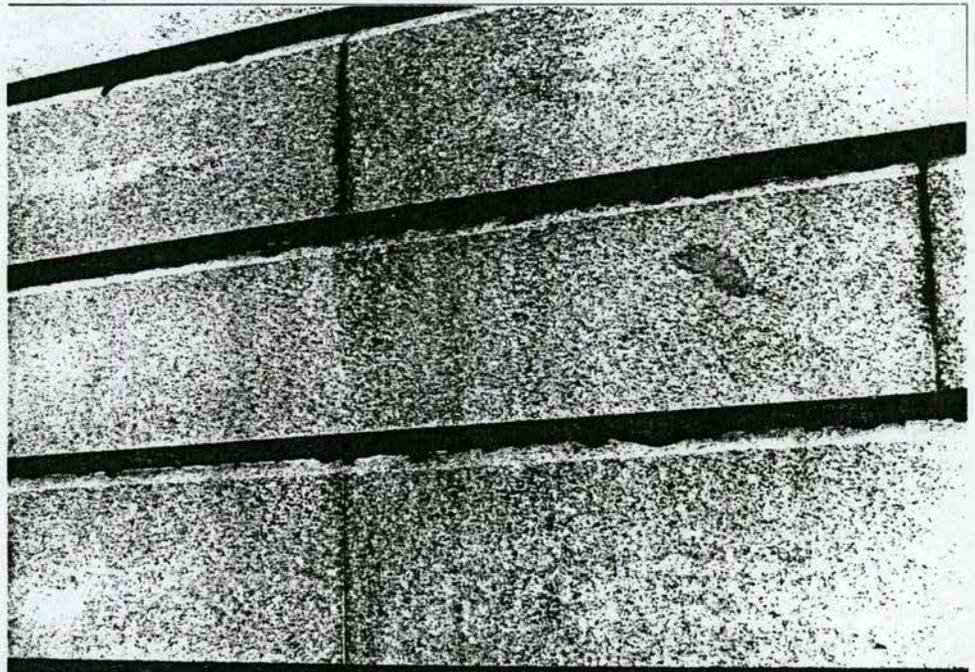
Photo 18 Note moss growth acting to accelerate deterioration of mortar joint.

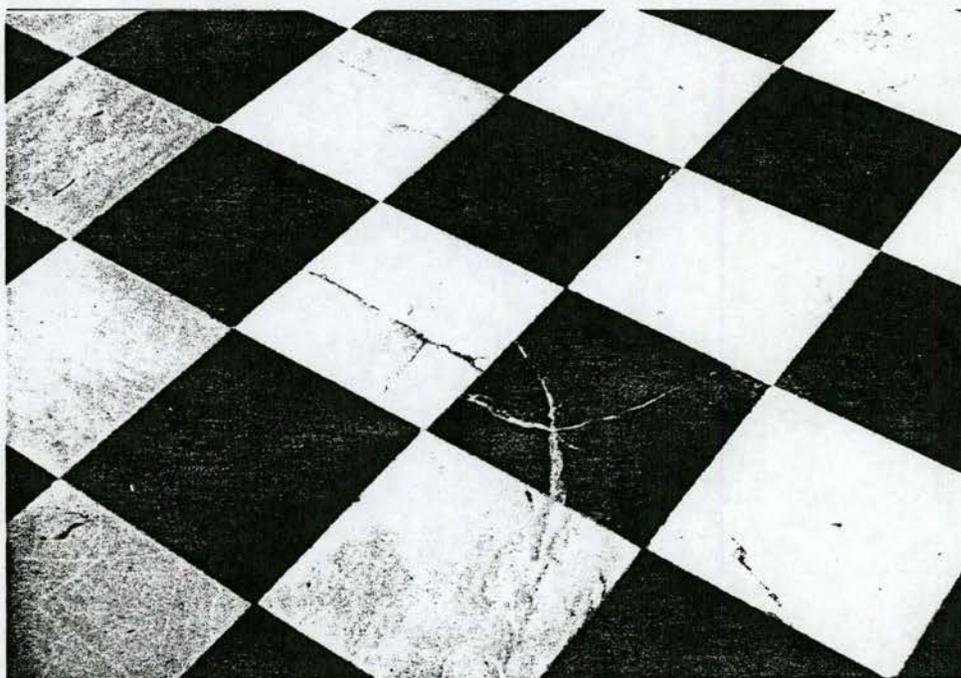
Photo 20 Note cracked surfaces of marble tile floors.

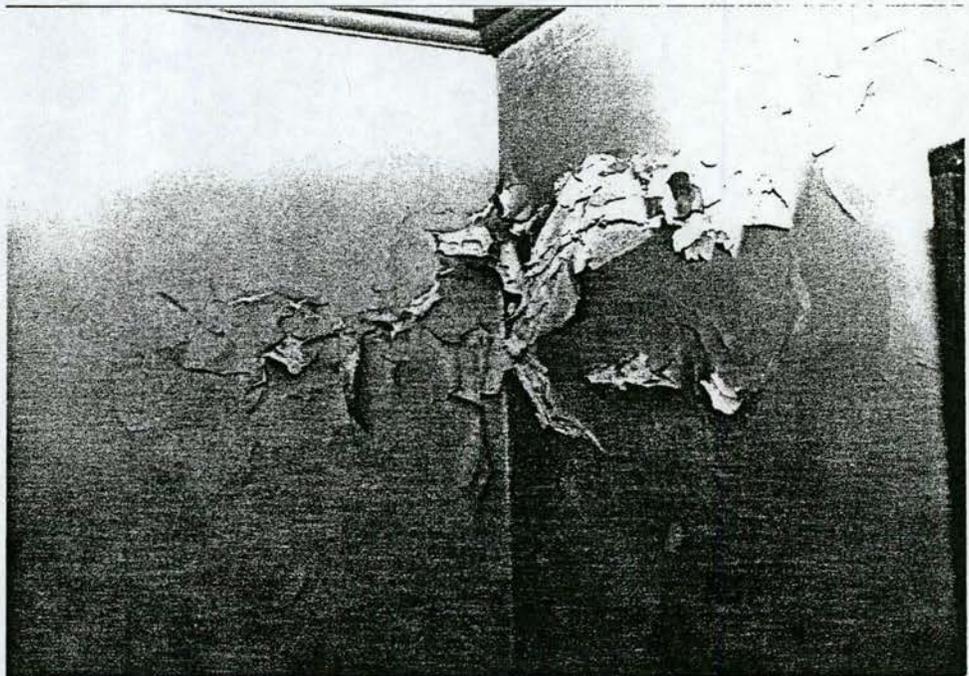
Photo 24 Note deteriorated plaster and peeling paint adjacent to internal roof drain.

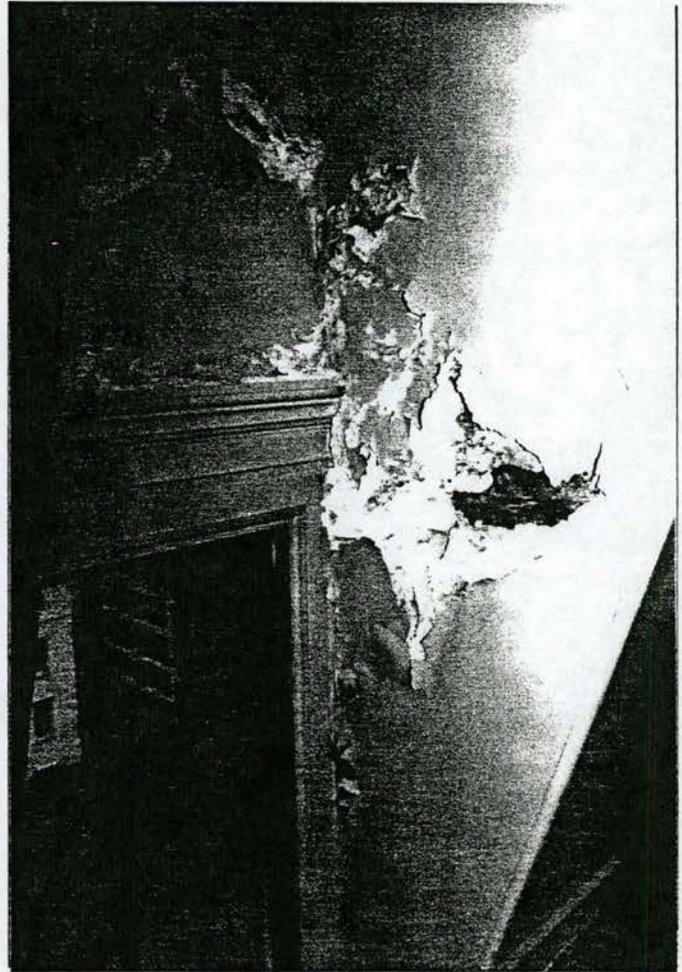
Photo 25

Note deteriorated plaster due to water penetration at dormer.
Plaster is applied directly to granite.

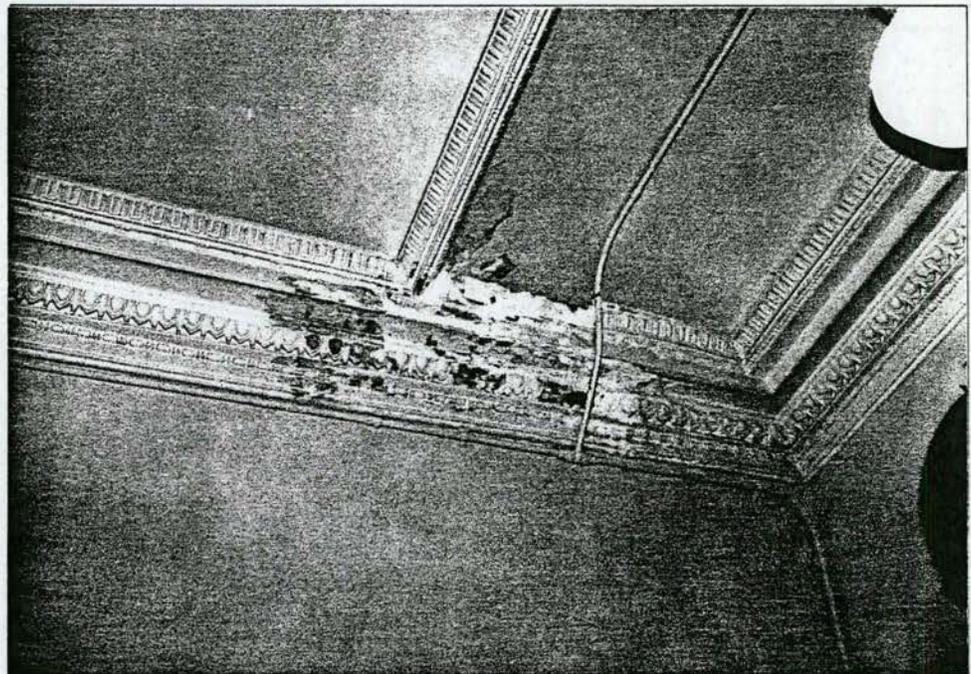
Photo 26

Note deteriorated plaster cornice adjacent to roof drain.

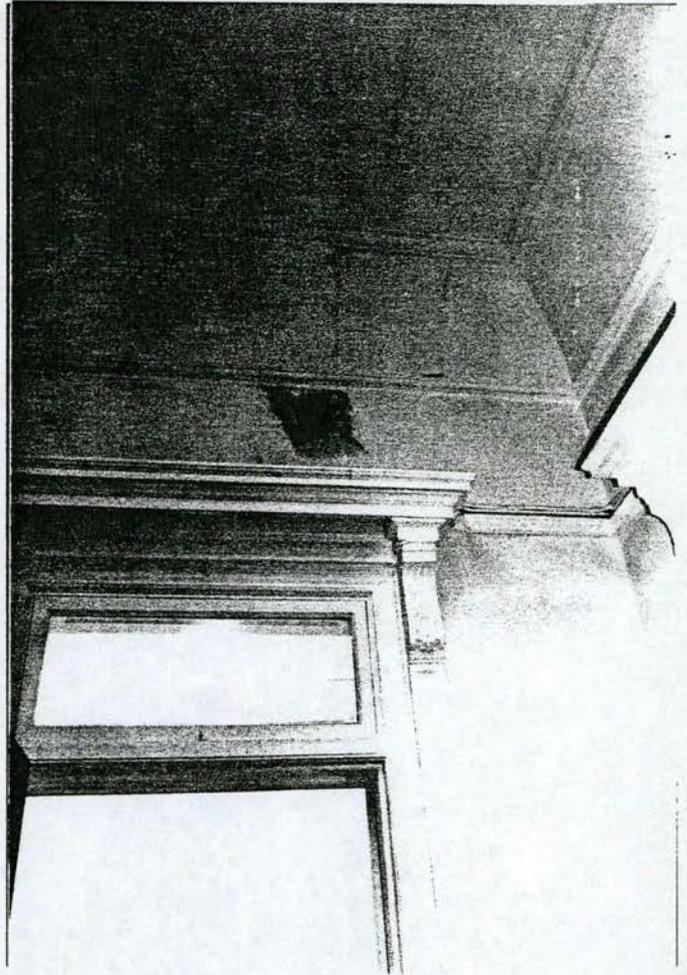
Photo 29

Note overpainted wood trim. Also note peeling lincrusta wall covering.

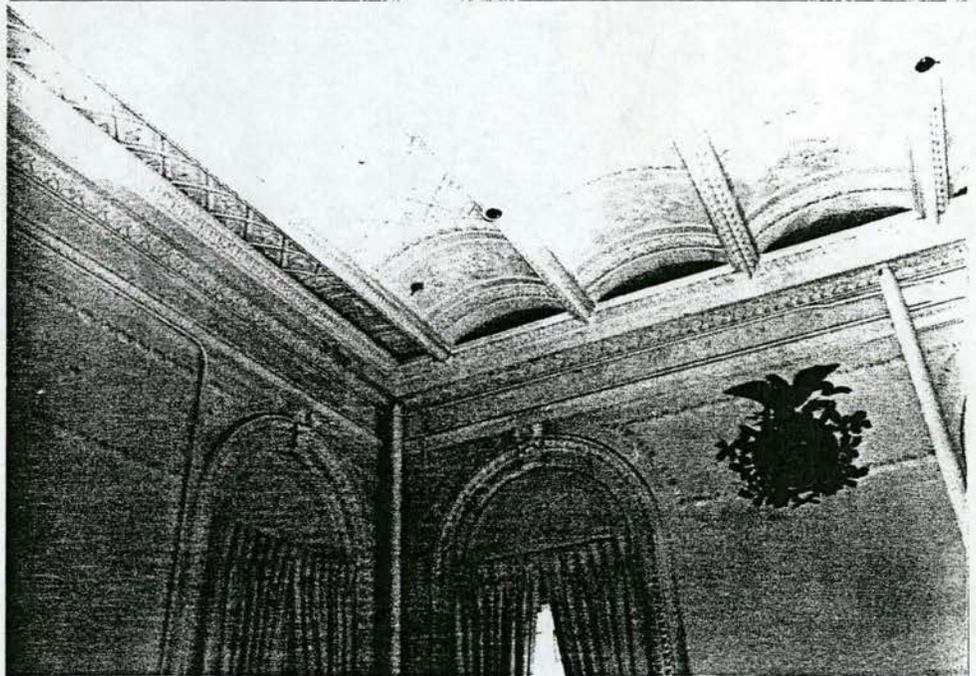
Photo 31

Note over-painting of lincrusta ceiling and walls which were probably historically polychromatic.

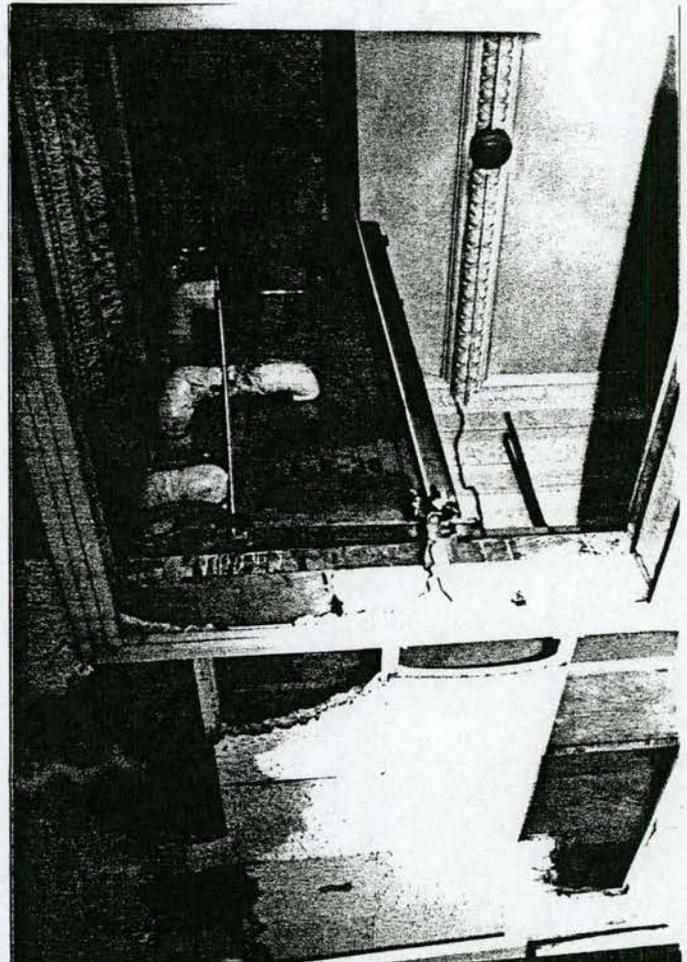
Photo 32

Note suspended ceiling, deteriorated ceiling tile, and inserted mechanical equipment. Note also that historic fabric, above, is intact.

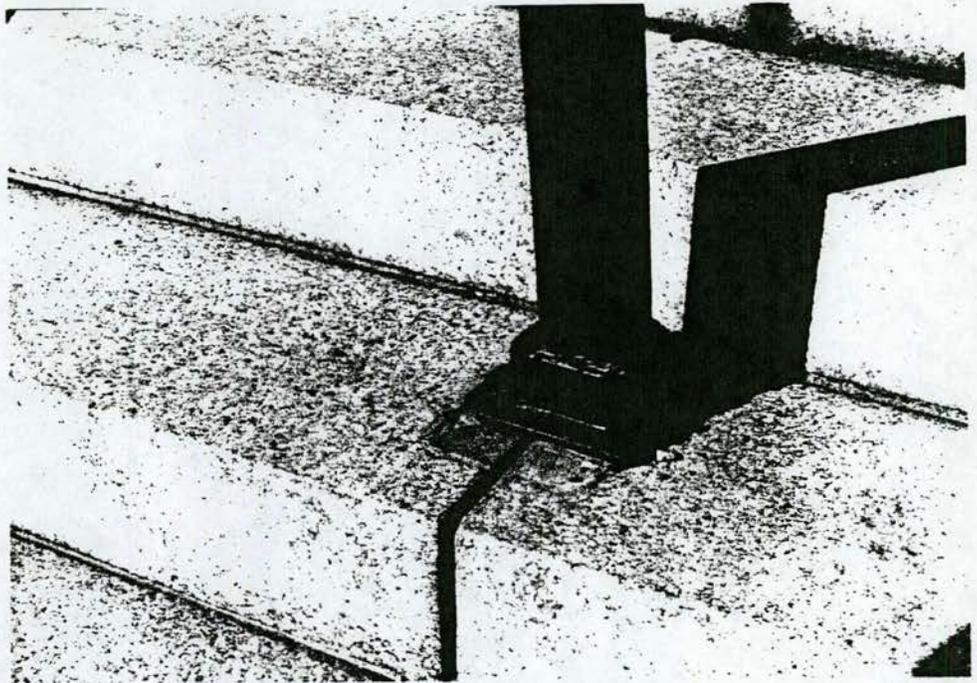
Photo 35 Note open joint between granite steps. Note also that iron railing post has been reset, indicating on-going movement of individual steps.

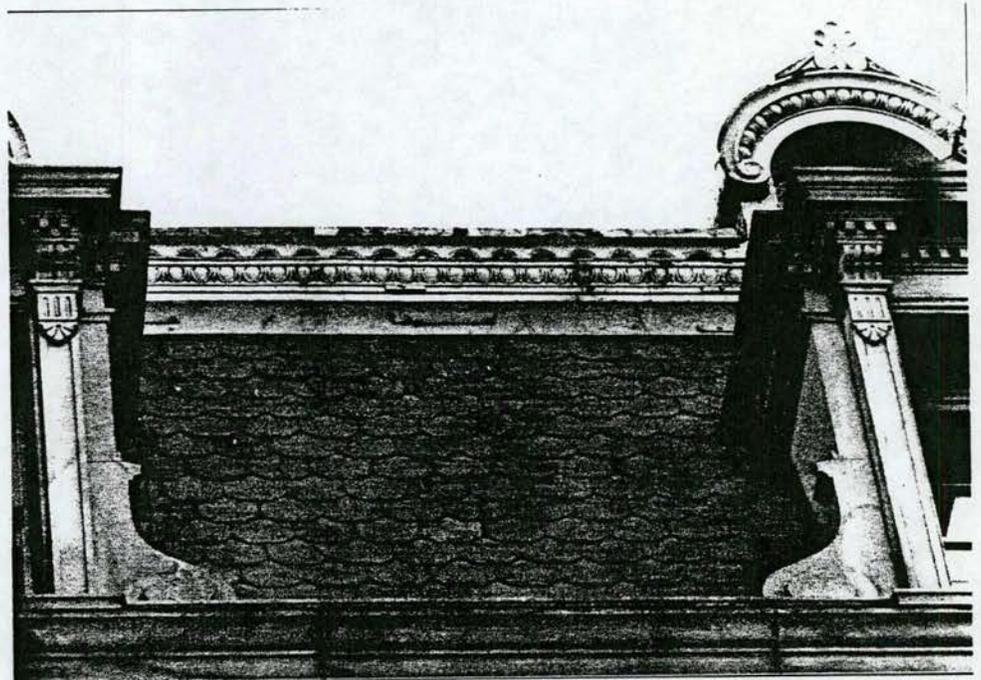
Photo 36 Note evidence of past repairs to cast iron ornament.

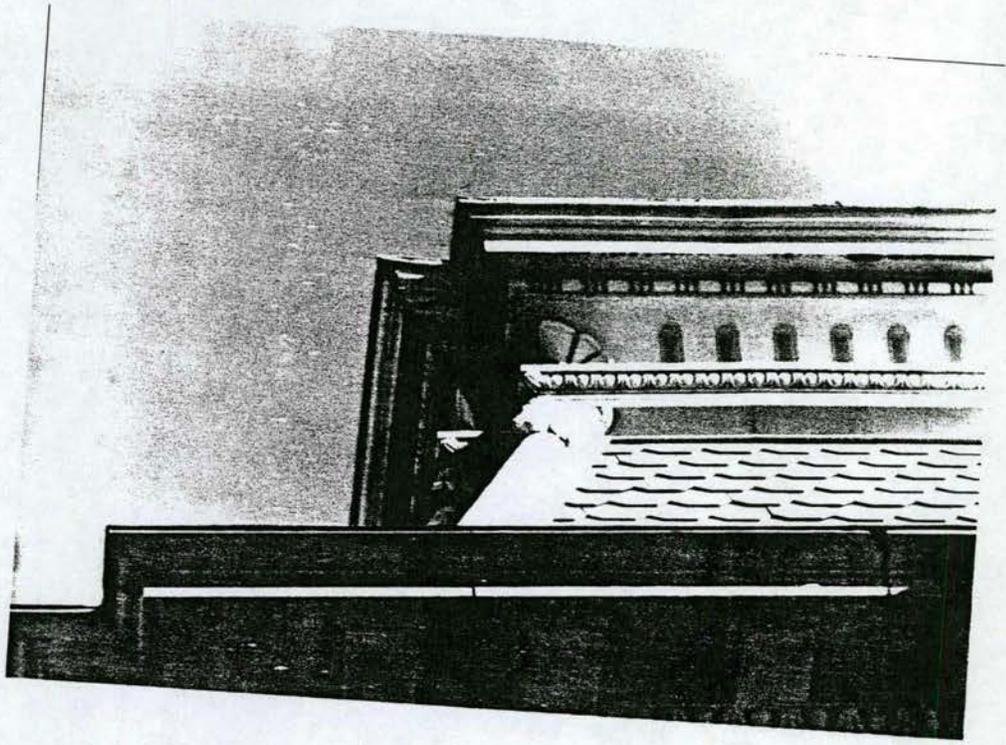
Photo 40

View of South elevation of OEOB showing missing sections of cast iron trim and stained and open mortar joints in raking ornament cornice.

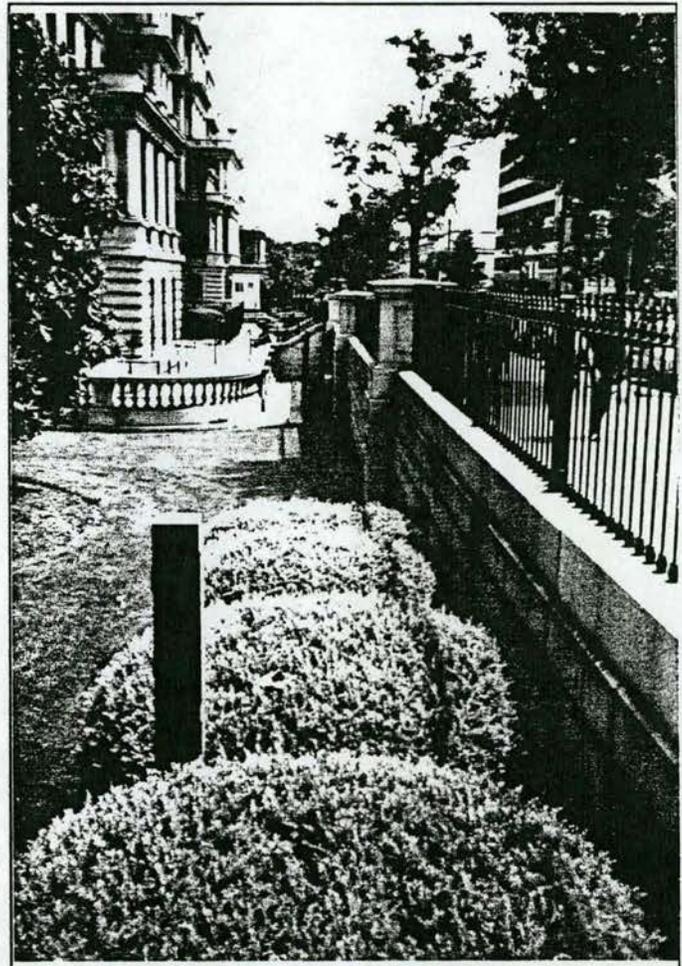
Photo 58

View of 17th Street retaining wall from the Pennsylvania Avenue
sidewalk. Note slight over-turning of wall and masonry piers.

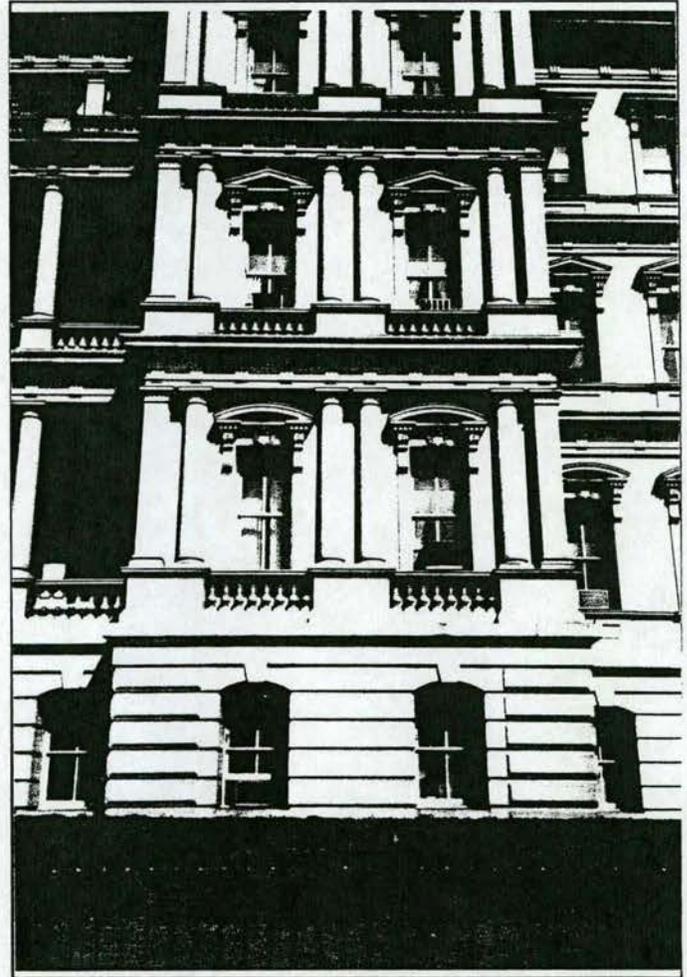
Photo 59

View of west elevation of OEOB showing variable window condition, particularly, insertion of window air conditioning units.

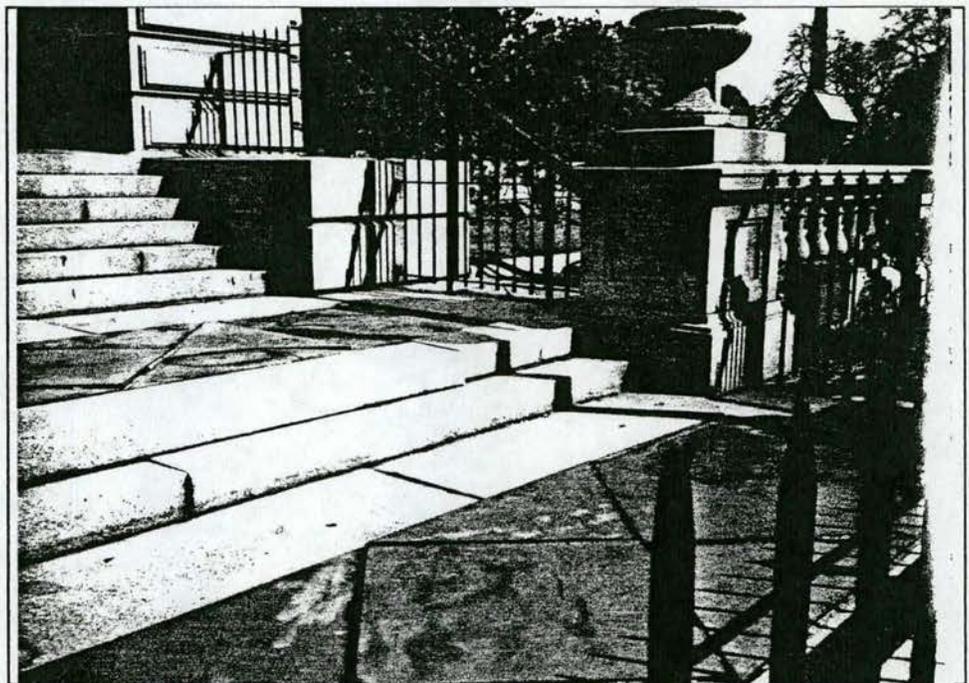
Photo 60

Southwest steps to OEOB along 17th Street. Note open joints and displacement at granite steps and deteriorated paving stone.

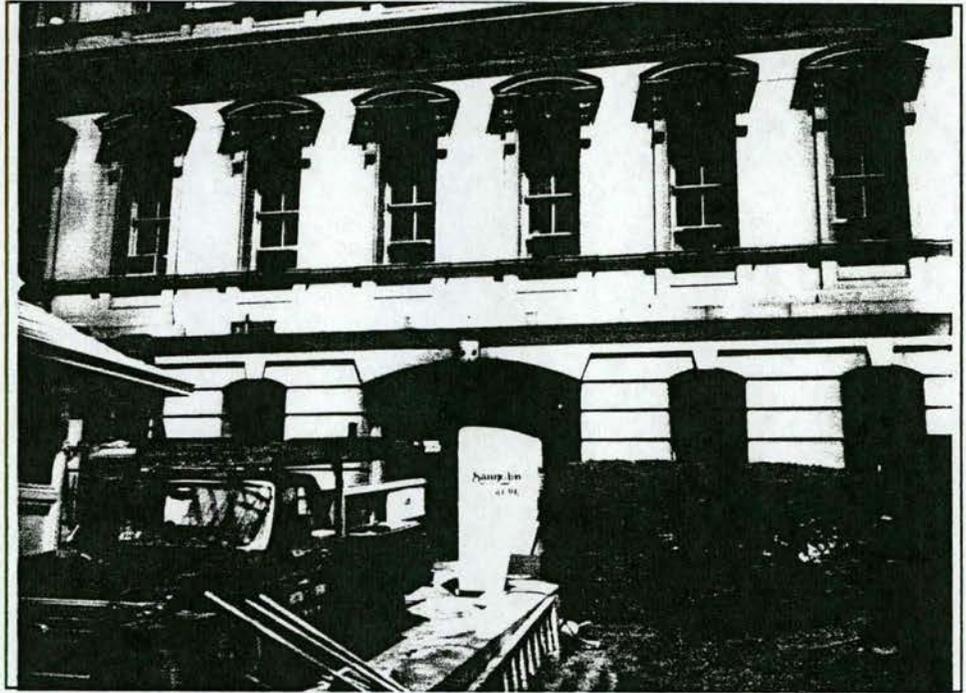
Photo 61 View of southern carriageway, west elevation with adjacent new construction of guard post. Note stained mortar joints and stone along protruding belt course immediately above carriageway. Also note condensate water from window air conditioning unit flowing over belt course above window left of carriageway.

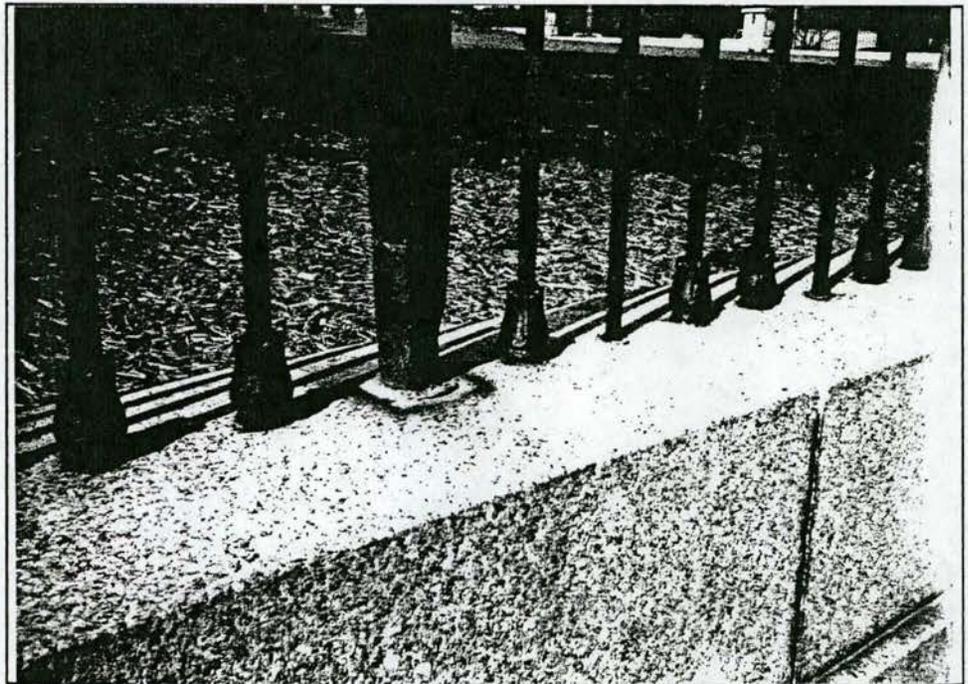
Photo 64 Deteriorated cast iron fencing along State Place. Note rusted, broken and missing elements and rust stains on granite.
