HISTORIC BUILDING PRESERVATION PLAN

Project No. RDC 24074

OLD EXECUTIVE OFFICE BUILDING

**FINAL REPORT
14 JUNE 1993**

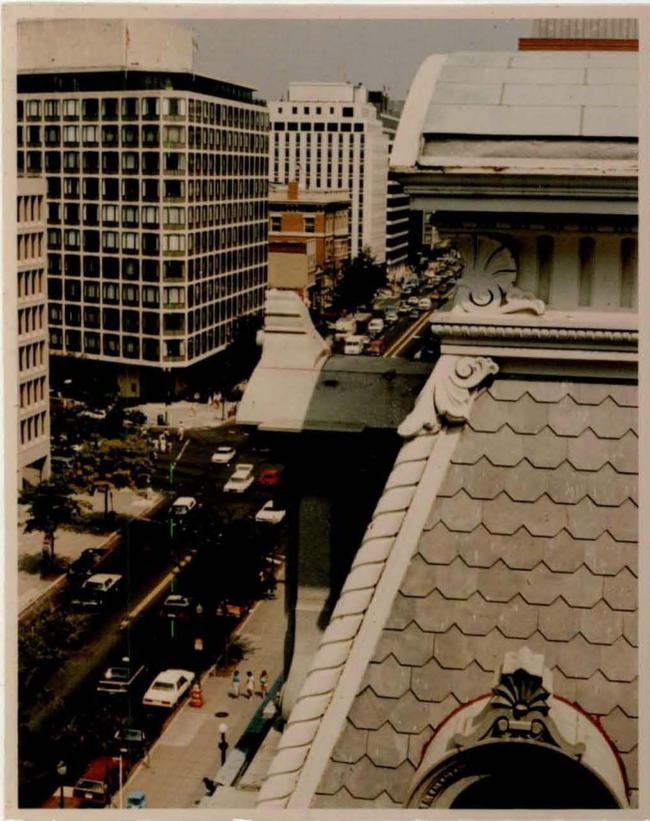
| CODE | ELEMENT | DESCRIPTION | I N V E N T O R Y | | |
|---|---|--|---|---|---|
| <p>Notes: Slates are very large, measuring 14" x 28" by 1/4" thick. They are anchored back to an iron substrate using bent wires. A single color is used throughout. There are twelve pavilions. In the 1992-95 roof restoration project, damaged slates are replaced with matching new ones.</p> | | | | | |

DC 003503
CAST IRON AND SLATE ROOFING DETAIL
OEOB
PHOTO TAKEN: 8/83

The roof and decorative elements are being restored and repaired in an extensive multi-year project which will be complete by 1994. Damaged cast iron is being replaced in kind and missing slate is being replaced. All new copper roofing for the upper low slope areas is being installed as well as all new copper flashing and gutters. The intent of the roof replacement project is to restore all historic features in kind with the result being a very long service life for the roof assembly.

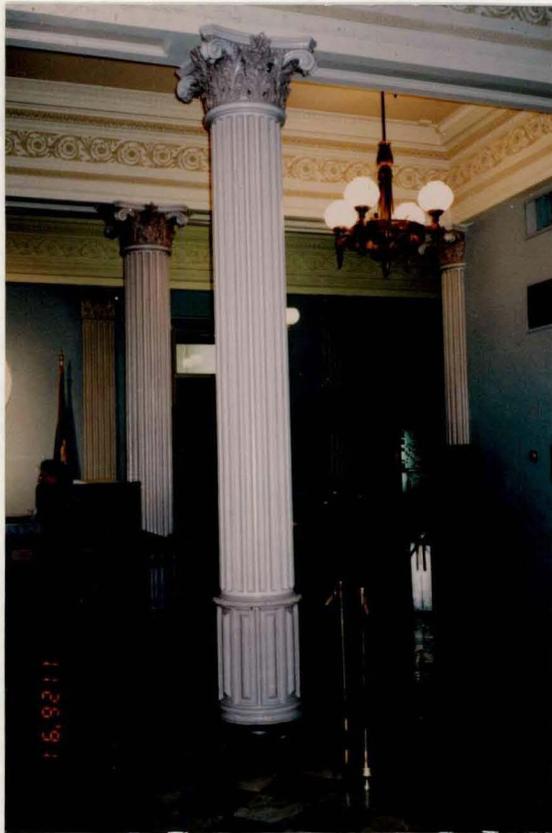
DC 003519
INTENDED FIRST FLOOR LOBBY APPEARANCE
OEOB
PHOTO TAKEN: 11/91

Slide no. DC003519 illustrates the Pennsylvania Avenue lobby condition, indicating the original configuration with free standing cast iron columns. Photos of the unrestored East, South and West lobbies were not available.

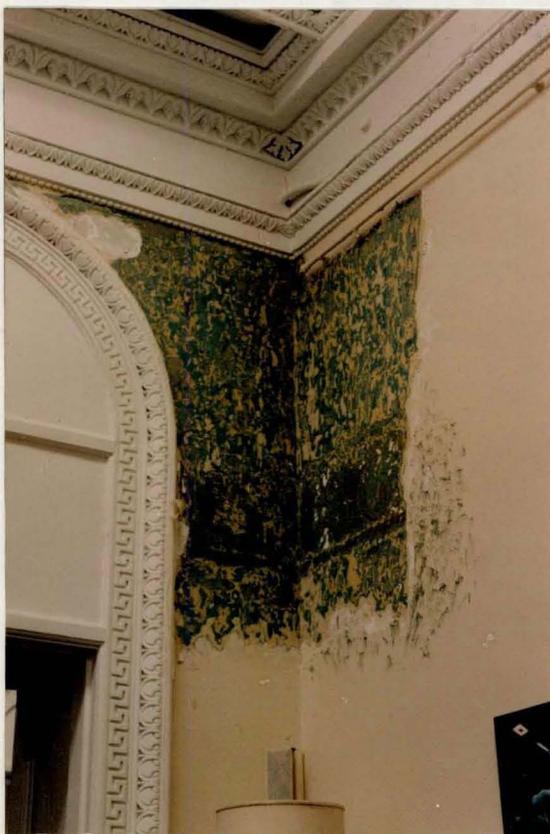
DC 003521
CONCEALED DECORATIVE FINISHES (RM. 278)
OEOB
PHOTO TAKEN: 4/92

The office suites on either side of the double loaded corridors retain most original features and elements, but most have been painted a monochrome white color, obscuring original decorative paint and stencil finishes. These rooms include the same cast iron door and window trim and plaster ceiling cornices found in the major ceremonial spaces and the public corridors. Some offices have been subdivided with modern partitions. Some ceilings have been dropped with modern suspended acoustical tile ceilings.

Original building features should be maintained and if the rooms are to be redecorated in the future, consideration should be given to restoration of original paint and stencil finishes. The extent of these decorative finishes on a room by room basis is not known, but in many locations where the white paint has been removed, there has been found some form of decorative paint finish. Slide no, DC003521 illustrates this hidden condition in one room.
