# **A Glossary of Historic Masonry Deterioration Problems and Preservation Treatments**

Department of the Interior  
National Park Service  
Preservation Assistance Division

1984

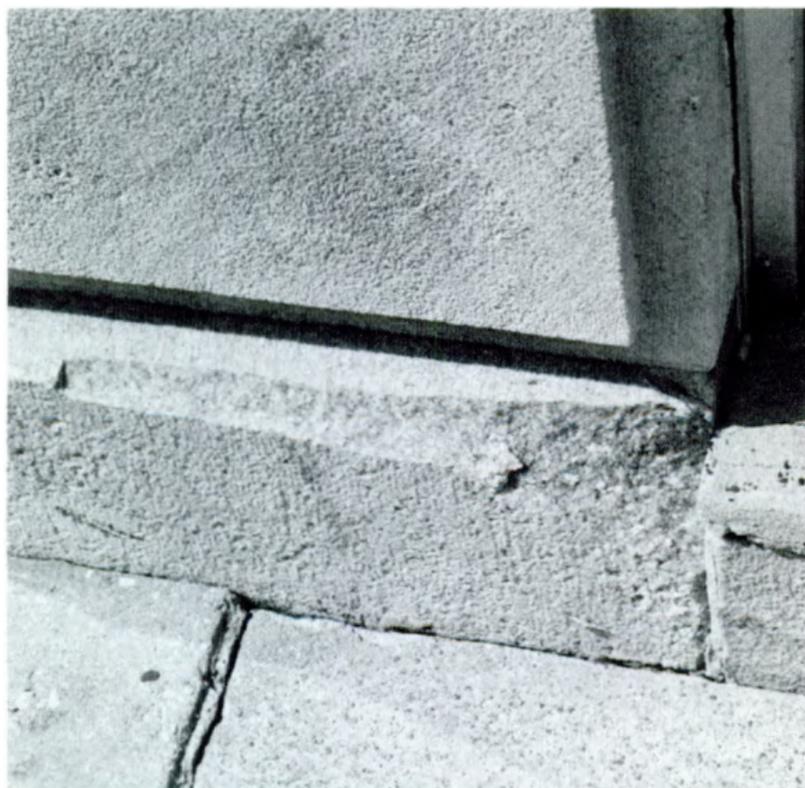
Small pieces or larger fragments of masonry separating from the masonry unit, often at corners or mortar joints. This may be the result of damage caused by later alterations or repairs, such as use of too hard a mortar, or by accident or through vandalism.

*Chipping of granite sill. Photograph: Anne E. Grimmer.*

*Preservation Treatment:* See Dutchman Repair, p.56; Replacement/Patching with Like or Compatible Substitute Materials, p.59.

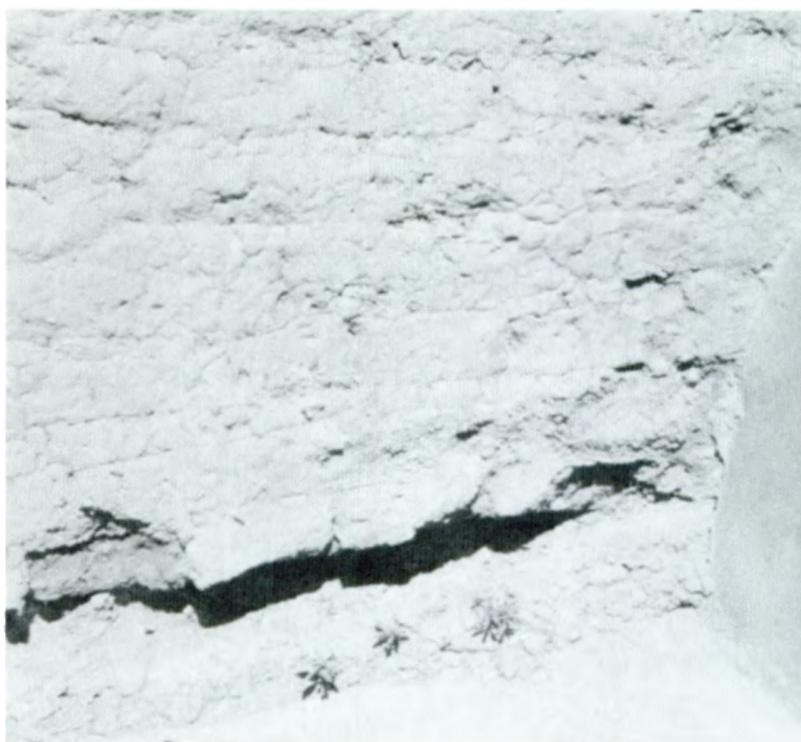
The hollowing out of an adobe wall just above grade level. Coving may be caused by standing rainwater or rainwater splash off the ground. It can also be caused by salts deposited in the adobe by the evaporation of water.

*Coving of adobe wall. Photograph: National Park Service.*

*Preservation Treatment:* See Replacement/Patching with Like or Compatible Substitute Materials, p.59.

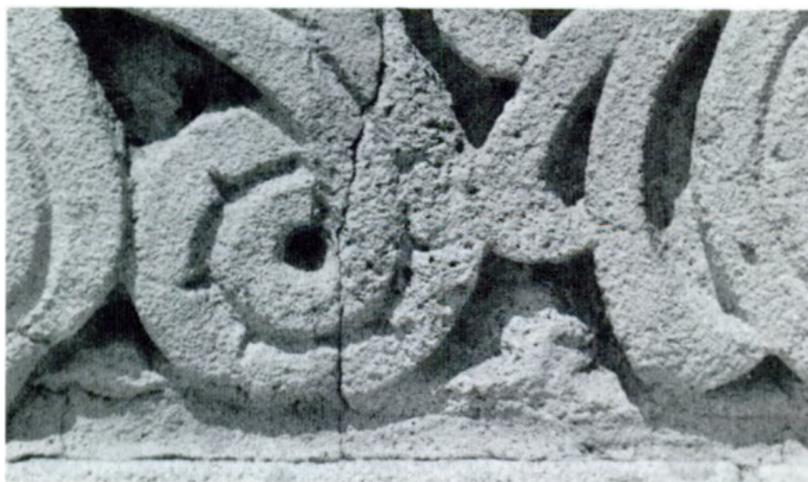
A term describing narrow fissures from 1/16 to 1/2 inch wide in a block of masonry. Cracking may result from a variety of conditions, such as structural settlement of a building, too hard a repointing mortar, or it may be an inherent characteristic of the masonry itself, such as unfired brick or adobe. Small cracks within a single block of masonry may not be serious, but longer and wider cracks extending over a larger area may be indicative of structural problems, and should be monitored.

*Cracking of limestone. Photograph: John H. Myers.*

*Preservation Treatment:* See Mechanical Repair, p.58; Replacement/Patching with Like or Compatible Substitute Materials, p.59.

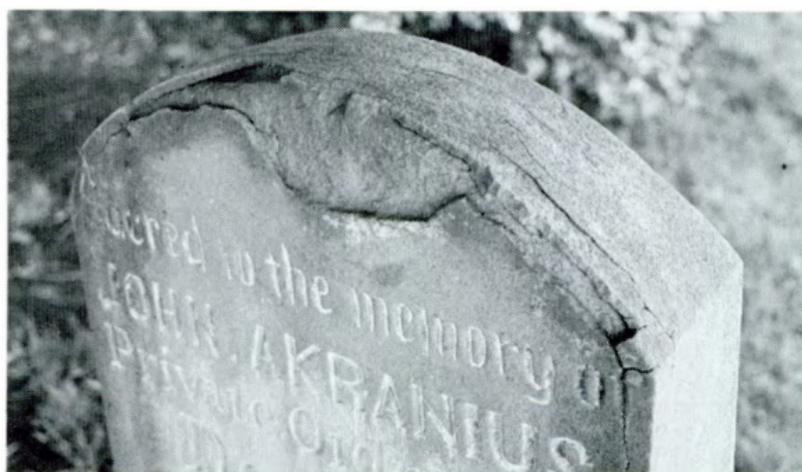
A condition of stone in which the outer surface of the stone splits apart into laminae or thin layers and peels off the face of the stone.

When sedimentary stones are used in building, this tendency to peel off in layers can be exacerbated by improperly laid stones. Delamination takes place along the natural bedding planes of the stones when they are laid vertically, instead of horizontally—the correct way—and, as a result, are exposed to weathering.

*Delamination of sandstone along the bedding planes.  
Photograph: U.S. Corps of Engineers.*

*Preservation Treatment:* See Stucco, p. 33; Composite Patching/Plastic Repair, p.50; Mechanical Repair, p.58; Replacement/Patching with Like or Compatible Substitute Materials, p.59.

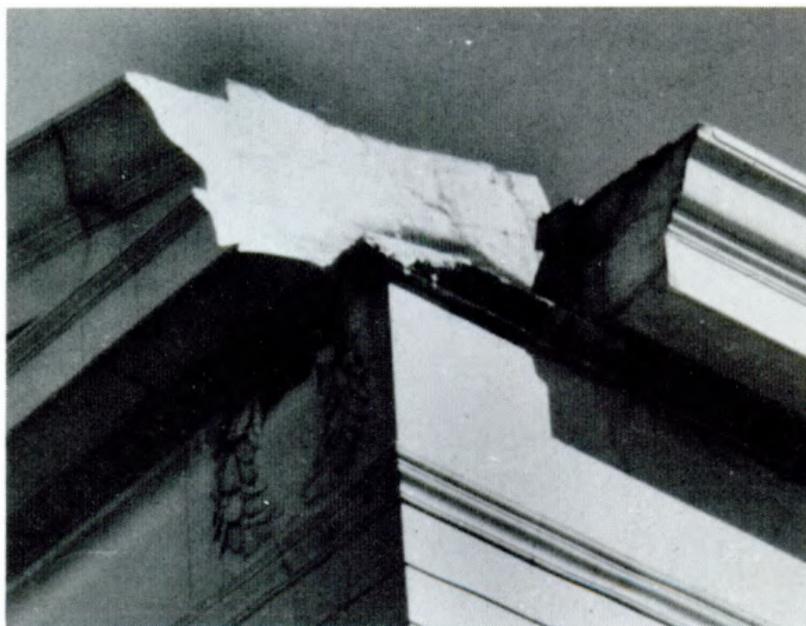
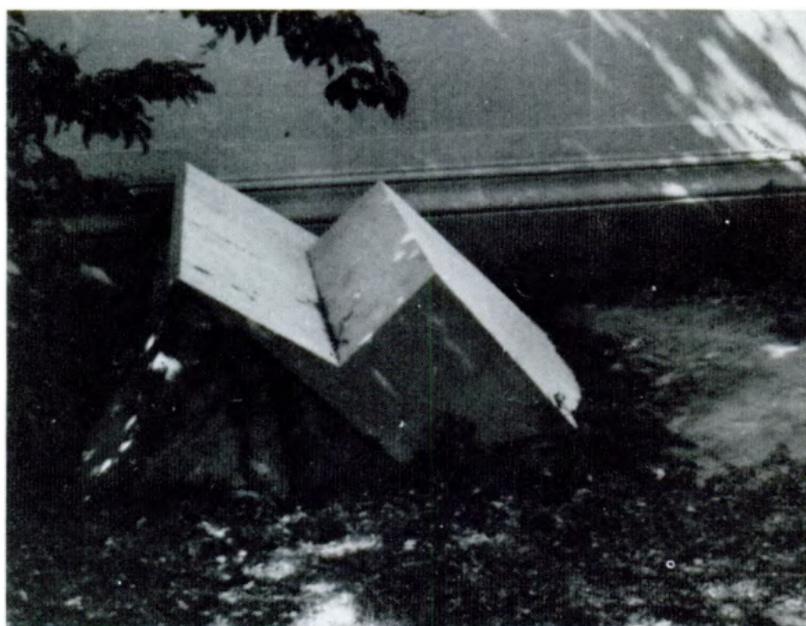
The result of a complete break (or failure of an original construction joint) in which the detached portion of masonry survives intact.

*Detachment of section of marble pediment. Photograph: Walter Smalling.*

*Section of marble lying on the ground at base of building after it had separated from pediment above. Photograph: Walter Smalling.*

*Preservation Treatment:* See Mechanical Repair, p.58.

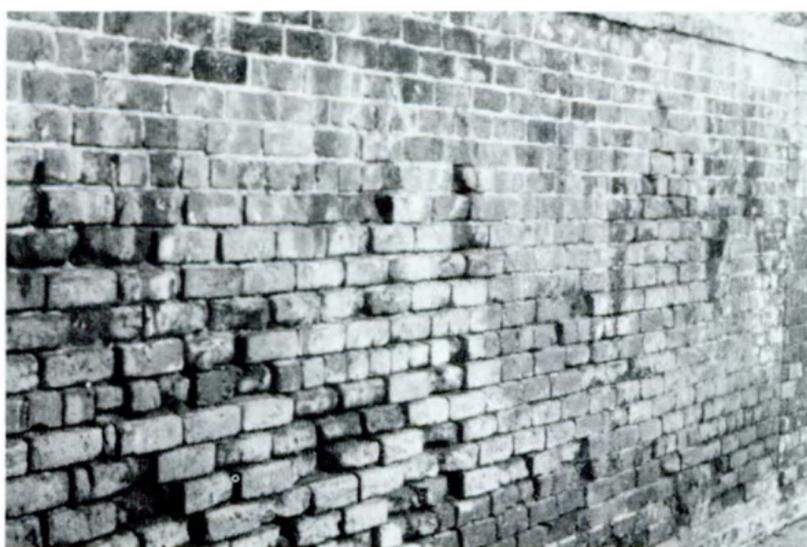
A whitish haze of soluble salts on masonry generally caused by excessive "pulling" of soluble salts into the masonry and out through the surface. Capillary action may pull soluble salts which result in efflorescence from the ground into the masonry, such as chlorides from salting of streets and sidewalks in winter and nitrates from fertilizers. In addition, carbonates from lime mortar and air-borne or water-deposited pollutants in the atmosphere may cause sulfates to be deposited on the surface of the masonry. Sulfates resulting from the curing and firing process are a common source of efflorescence in brick. Finally, efflorescence may be a combined salt residue left on the masonry surface by chemical cleaning, too strong a chemical solution, or improper rinsing.

*Efflorescence and spalling on brick wall. Photograph: Anne E. Grimmer.*

*Preservation Treatment:* See Poulticing, p.44; Water Washing, p.46.

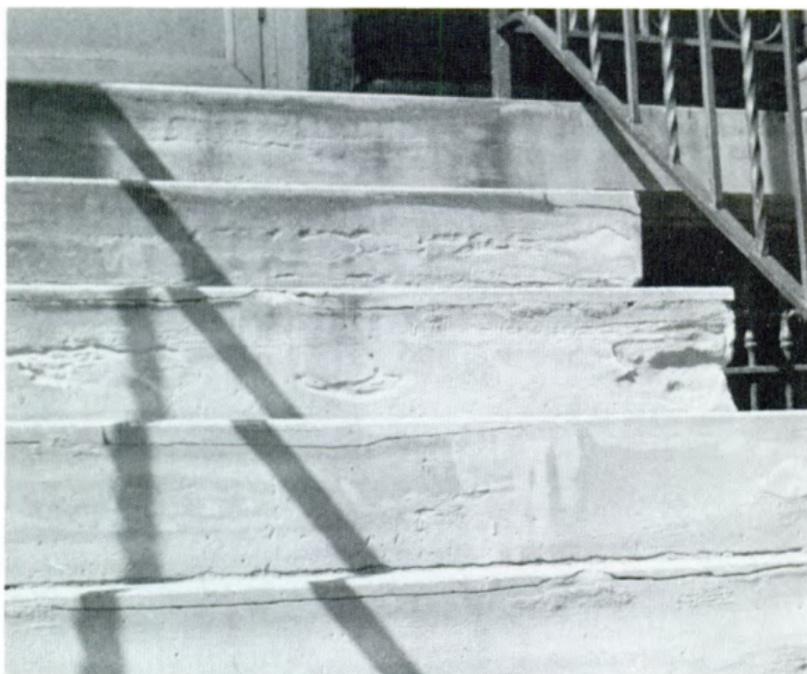
Wearing away of the surface, edges, corners or carved details of masonry slowly and usually by the natural action of wind or windblown particles and water. Erosion is one of the most serious kinds of adobe deterioration.

*Differential erosion of sandstone steps follows bedding planes of greater and lesser resistance. Photograph: Anne E. Grimmer.*

*Preservation Treatment:* See Replacement/Patching with Like or Compatible Substitute Materials, p.59.

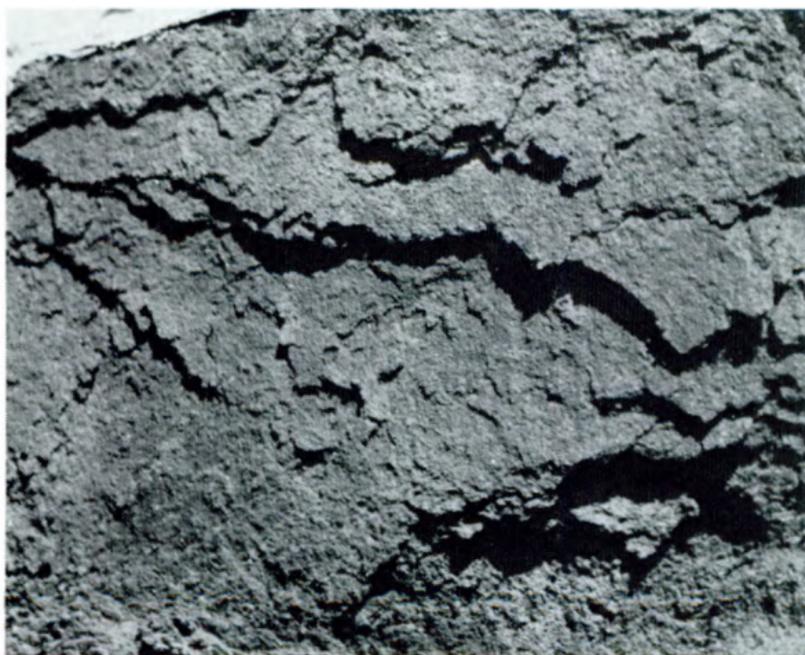
Exfoliation, like delamination, is a term primarily used to describe natural stone deterioration. Peeling, scaling or flaking off of the surface of stone in thin layers is caused by the expansion and contraction of trapped moisture, by chemical action such as rusting of metal, or by weathering. Exfoliation most often occurs along natural bedding planes, resulting in an unevenly layered surface. Incorrectly laid stones with their bedding plane laid up parallel or perpendicular to the surface of the building thus have a natural tendency to exfoliate faster, following the lines of the bedding planes.

*Exfoliation of sandstone. Photograph: Anne E. Grimmer.*

*Preservation Treatment:* See Stucco, p.33; Composite Patching/Plastic Repair, p.50; Mechanical Repair, p.58; Replacement/Patching with Like or Compatible Substitute Materials, p.59.

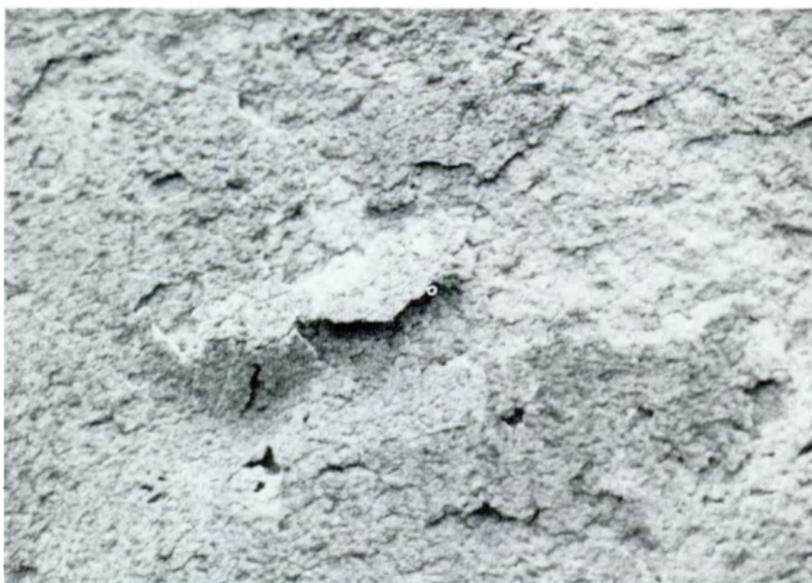
Flaking is an early stage of peeling, exfoliation, delamination or spalling, and is best explained as the detachment of small, flat, thin pieces of the outer layers of stone from a larger piece of building stone. Flaking is usually caused by capillary moisture or freeze-thaw cycles that occur within the masonry. The application of a water-repellent coating may result in flaking of the masonry when trapped moisture is forced to the surface.

*Flaking of granite. Photograph: Baird M. Smith, AIA.*

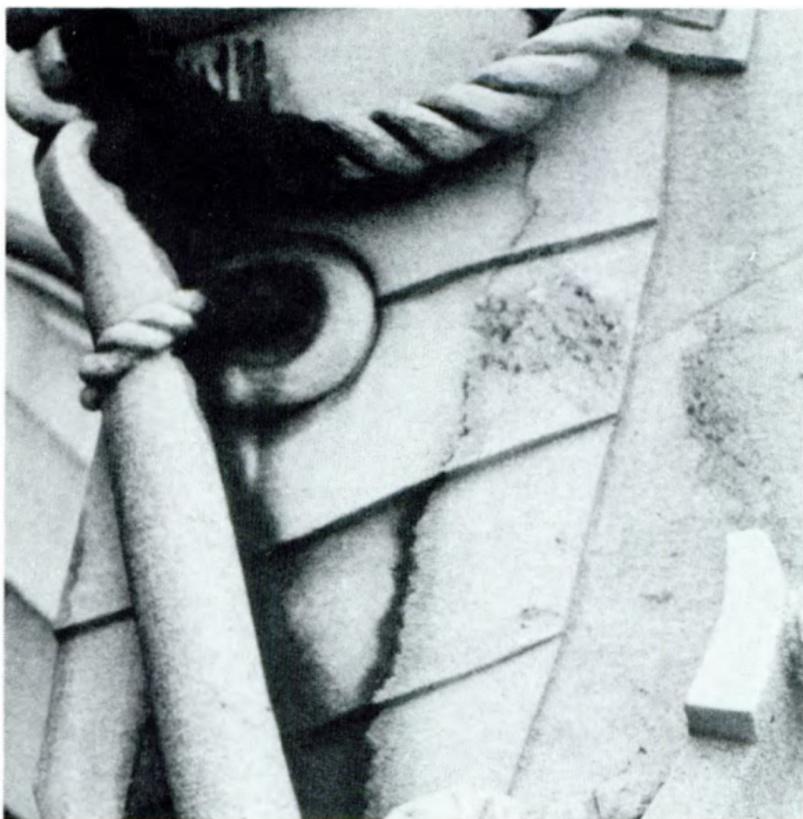
*Friability in limestone. Photograph: Anne E. Grimmer.*

*Preservation Treatment:* See Consolidation, p.52.

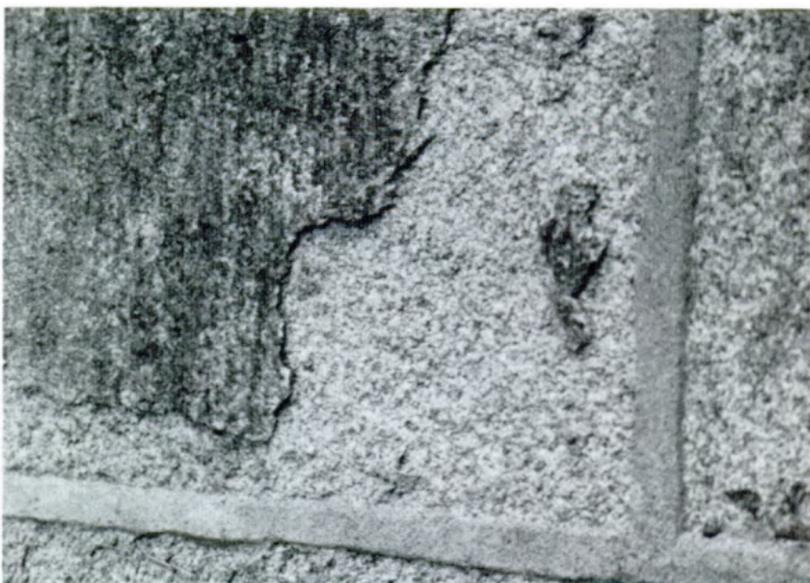
Peeling of stone may be caused by an inherent defect in the surface of the masonry or the result of weathering. Improper application of a masonry coating may result in a lack of adhesion to the substrate, and cause the surface of the masonry or coating to flake or peel away from the substrate in strips or layers.

*Peeling of granite. Photograph: Baird M. Smith, AIA.*

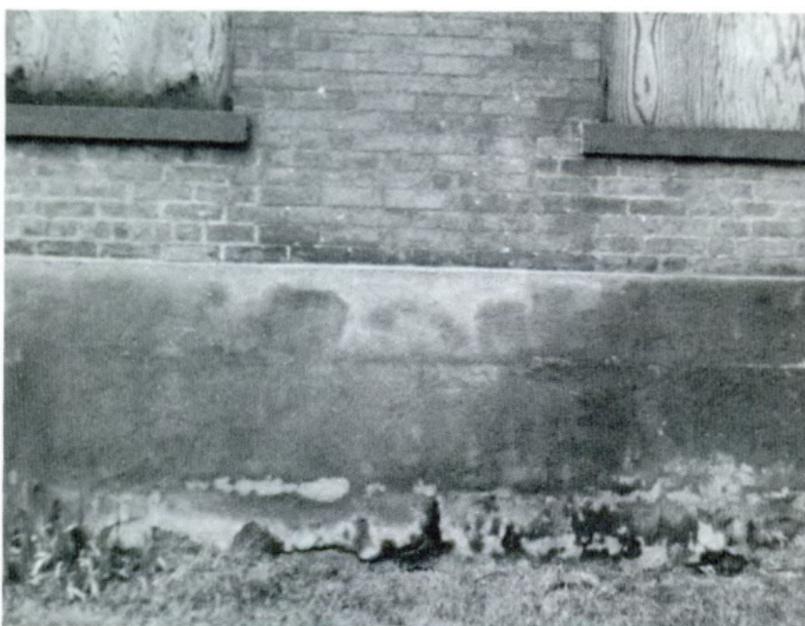
The suction of groundwater into the base of masonry walls through capillary action is called rising damp. Moisture is drawn up into the building walls and released at the interior and exterior surfaces where a horizontal wet stain or tidemark is left. The moisture often carries with it salts in solution, which can result in efflorescence and lead to deterioration of masonry, plaster, wood and paint. Rising damp, often the result of improper drainage, is a problem common to many older masonry structures, and one that is difficult to solve completely.

*Rising damp evidenced on parged foundation.  
Photograph: John Stubbs.*

*Preservation Treatment:* See Dampproof Course, p.54.

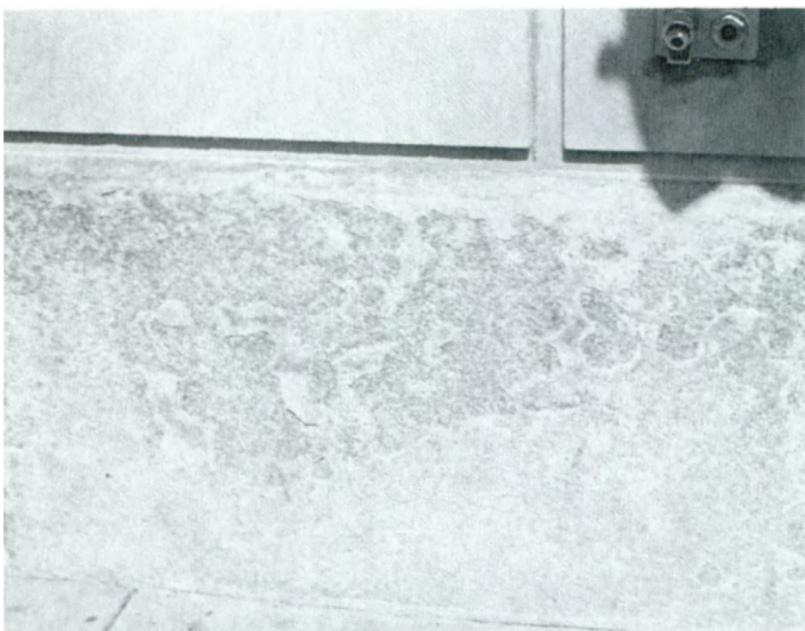
Sometimes called salt erosion, this condition results in an obvious pattern of erosion or etching of the stones caused by salt, usually from the salting of icy sidewalks. Unless the use of de-icing salts is discontinued, this condition can eventually result in spalling and exfoliation of the stone surface.

*Salt fretting on granite base probably resulting from use of de-icing salts on sidewalk. Photograph: Anne E. Grimmer.*

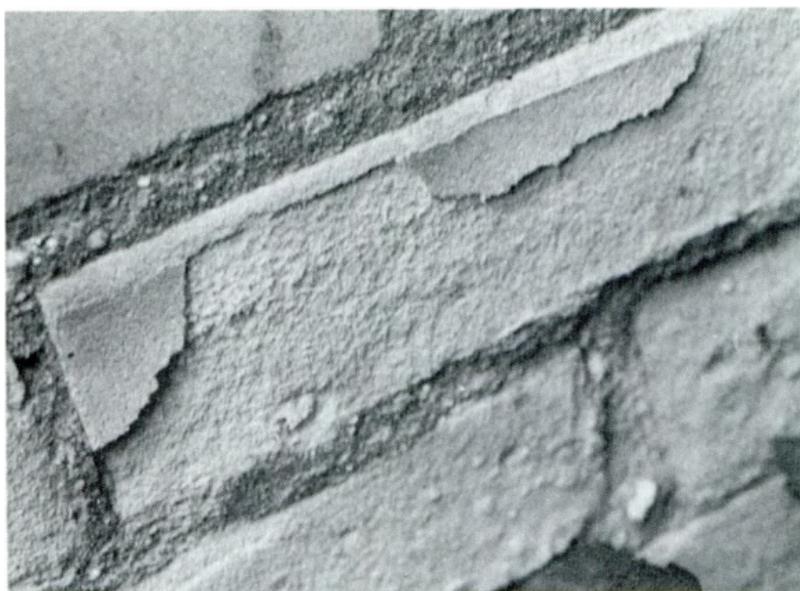
*Spalling of brick. Photograph: Susan Dynes.*

*Preservation Treatment:* See Stucco, p.33; Water-Repellent Coating, p.36; Composite Patching/Plastic Repair, p.50; Consolidation, 52

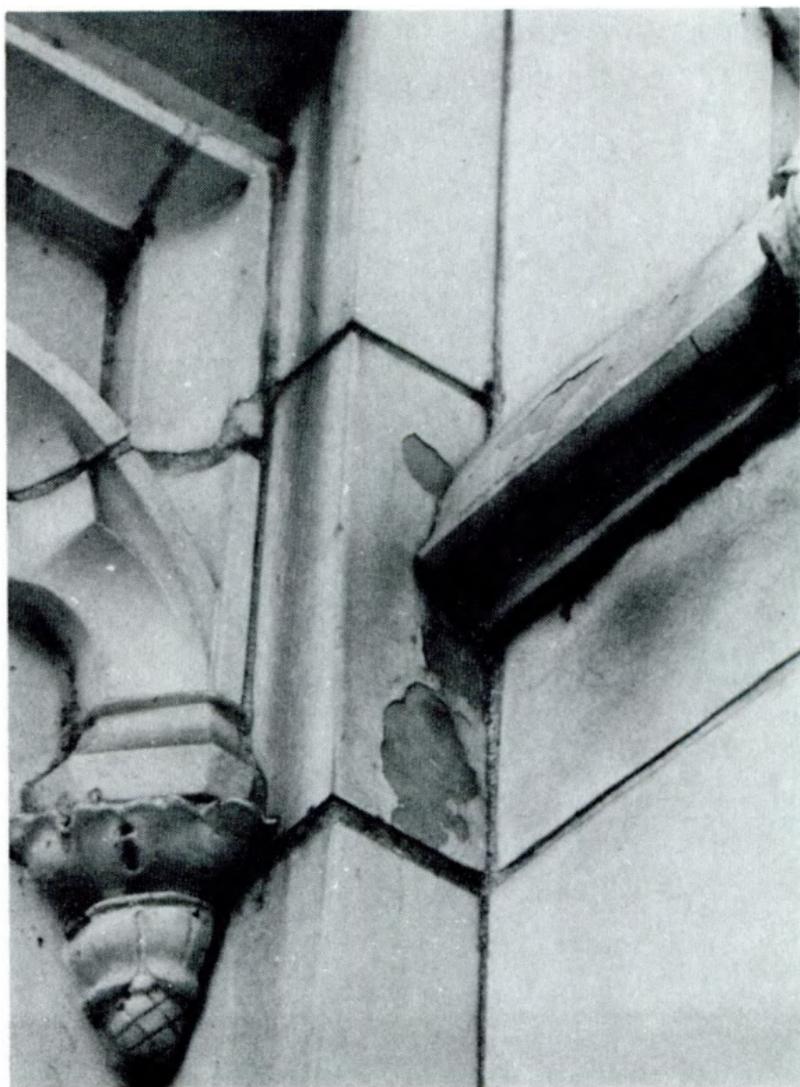
*Glaze spalling of glazed terra cotta. Photograph: John H. Myers.*

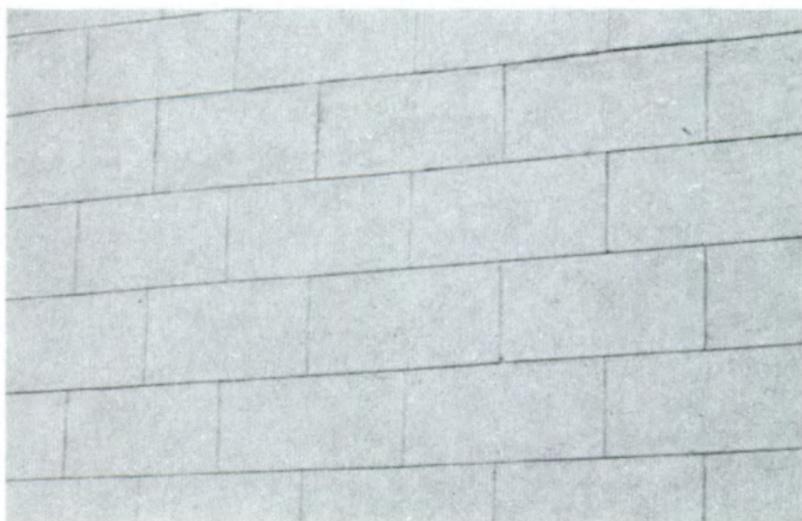
*Stucco scored to resemble blocks of stone. Photograph: Anne E. Grimmer.*

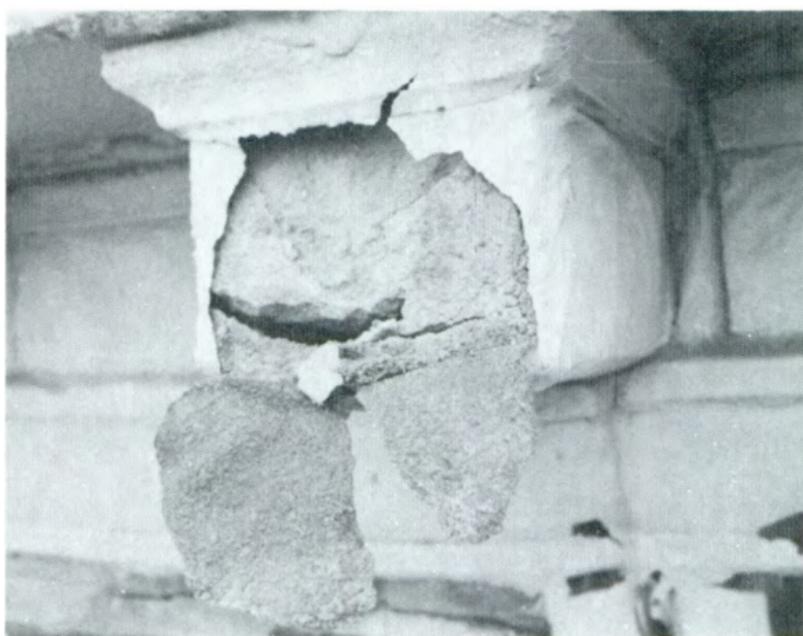
These coatings seal the masonry surface from both liquid water and water vapor; they may be clear or opaque—and include bituminous coatings such as those applied to building foundations, and also some paints. They generally do not cause problems as long as they exclude all water from masonry, but if water does enter the wall, the coating can intensify the damage to the wall because the water will not be able to escape. Basically, waterproof coatings make a surface *impervious* to water.

*A neoprene coating over a limestone cornice has trapped water (which entered through leaks in the parapet) inside these stone dentils. The built-up water pressure has finally forced the coating to pop off, taking with it pieces of the stone. Photograph: National Park Service.*

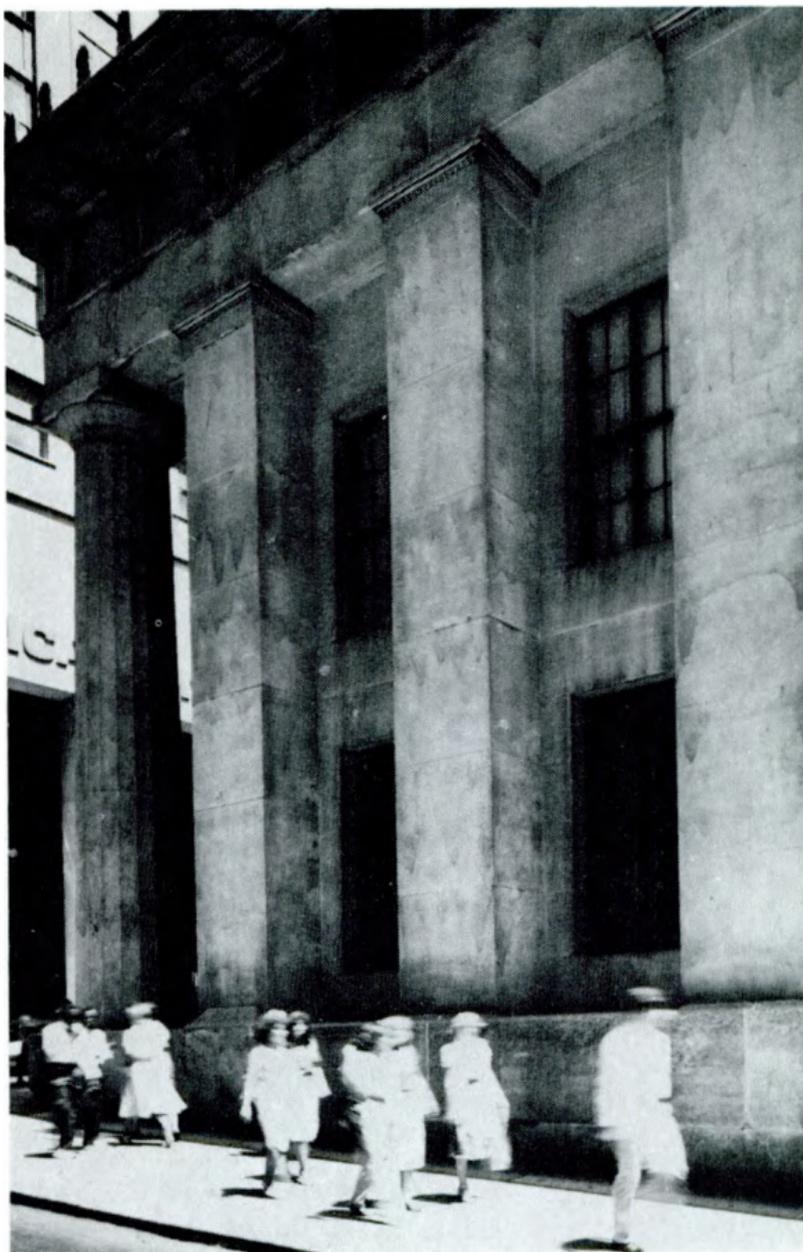
*Water-repellent coating improperly applied gives a blotchy appearance to the stonework. Photograph: Walter Smalling.*

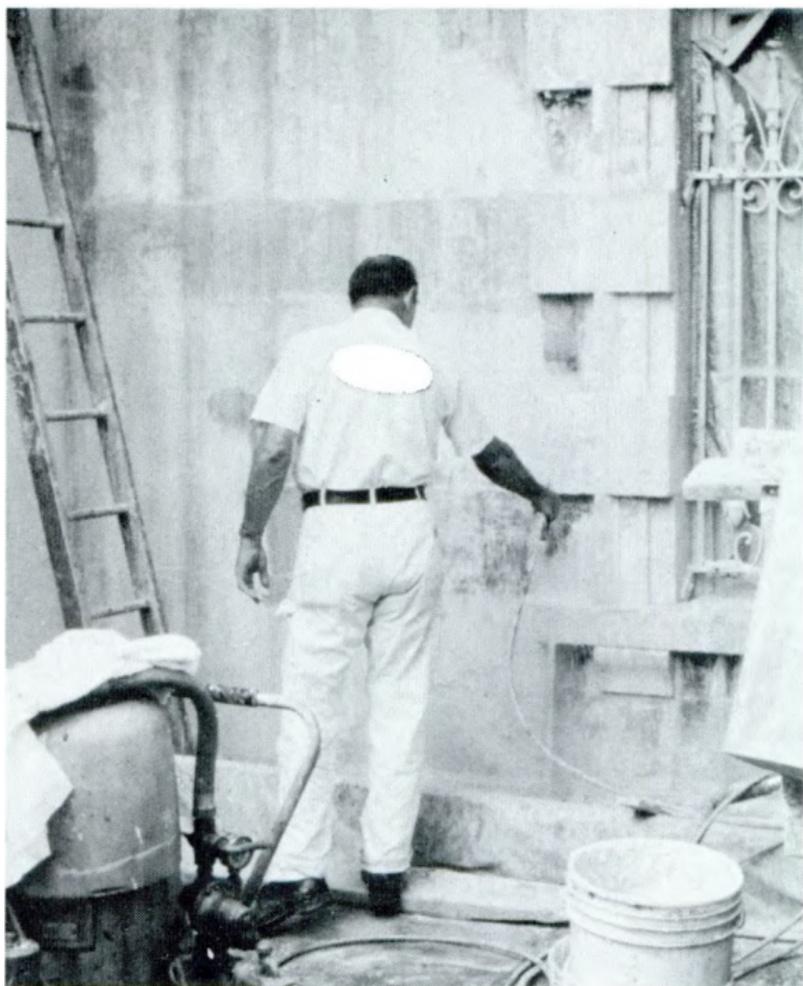
*Paint removal from sandstone. Photograph: Baird M. Smith, AIA.*

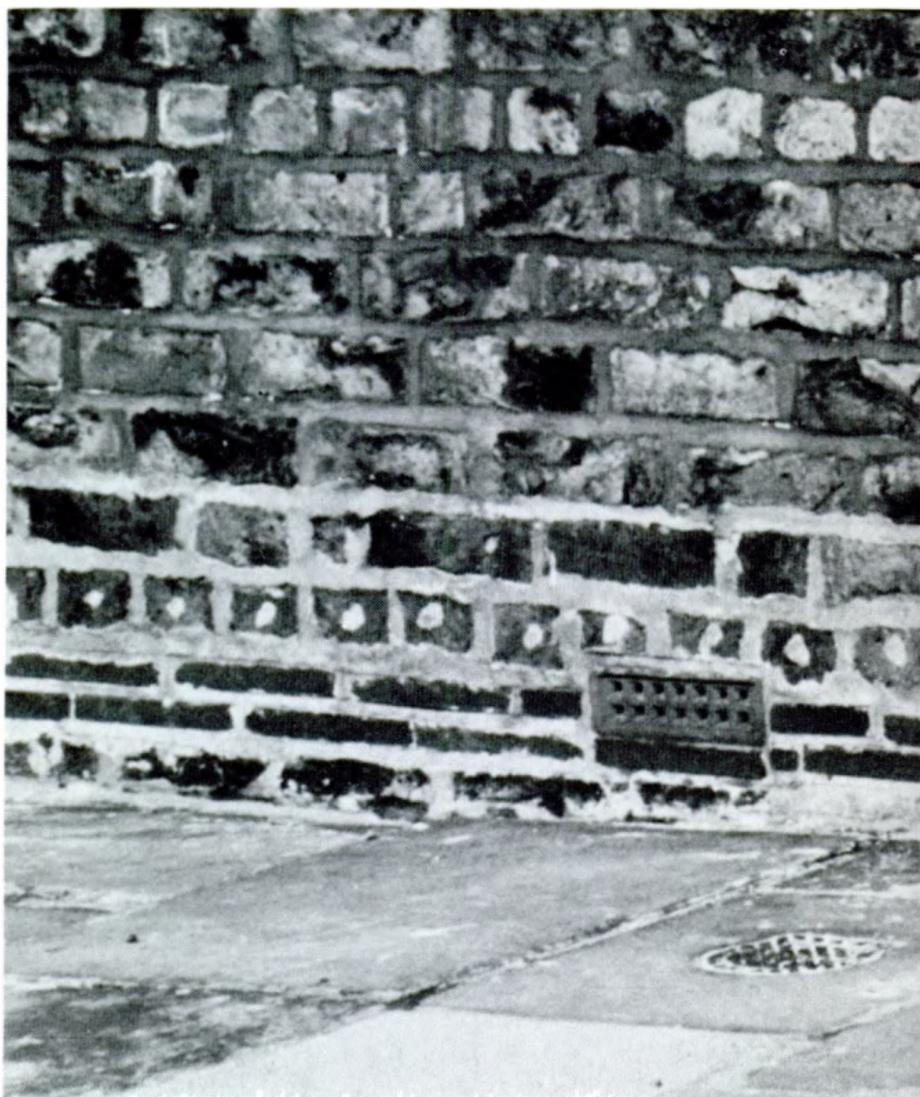
Installation in masonry of a horizontal layer of material which is impervious to water, such as tile, slate, lead-cored bituminous sheet or bituminized felt, polyethylene sheeting, or metal, to prevent the capillary rise of moisture—**rising damp**—from the ground into the masonry wall. Historically, some masonry buildings were constructed with a dampproof course, but usually dampproof courses must be added later as a remedial measure to correct problems caused by rising damp. A traditional dampproof course is not installed without difficulty, as a continuous horizontal course must be cut out of the mortar or brick at a level just above the ground and below first floor joists, and the dampproofing material inserted in an uninterrupted horizontal course. This system

*The horizontal row of white dots in the brick headers indicates that a chemical dampproof course has been injected. Photograph: Baird M. Smith, AIA.*
