EXHIBIT 18

STANDARDS FOR RESTORATION & GUIDELINES FOR RESTORING HISTORIC BUILDINGS

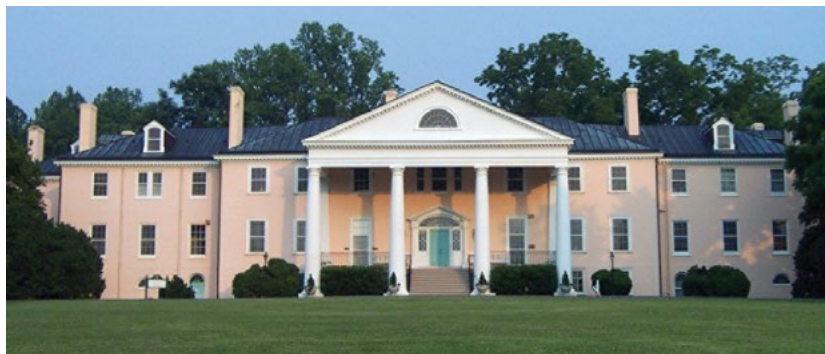
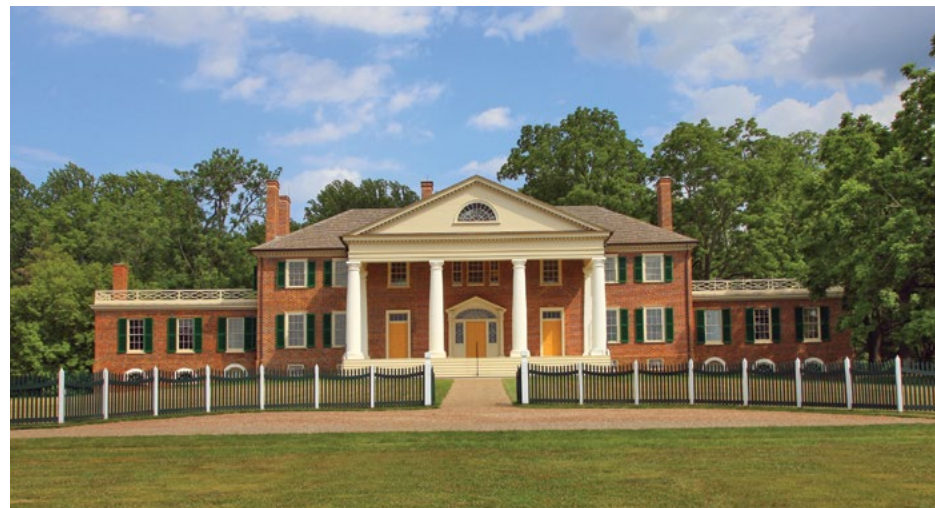
[1] (a) When it was acquired by the National Trust for Historic Preservation in the 1980s, Montpelier in Montpelier Station, VA, the home of James and Dolley Madison, had been much altered and enlarged since it was first constructed. Based on historical documentation and research, Montpelier was accurately restored to its 1820s appearance when the president and his wife lived there (b). *Photos: Courtesy of The Montpelier Foundation.*

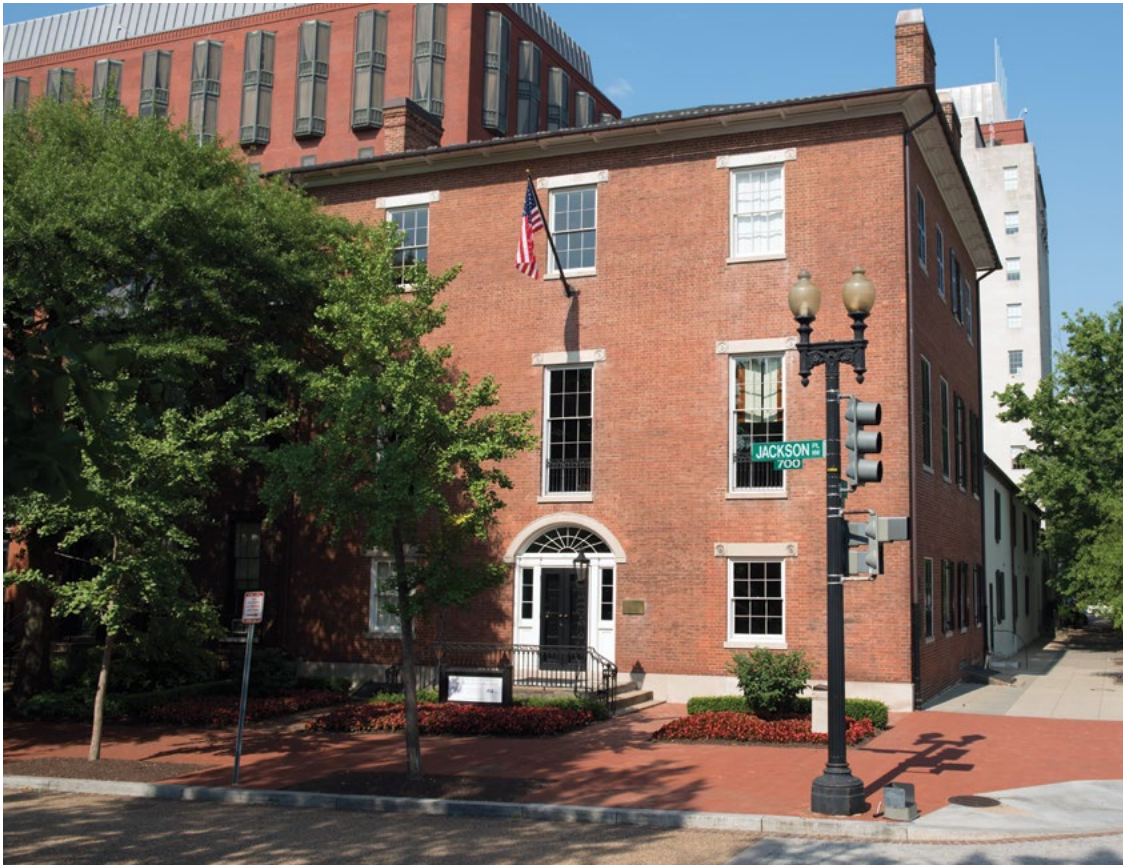
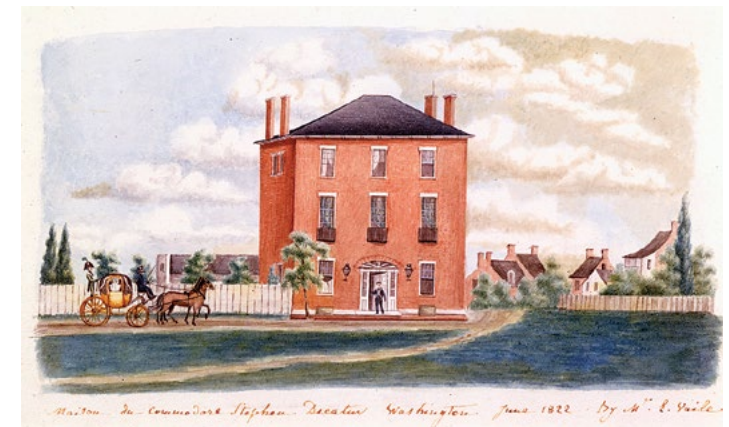
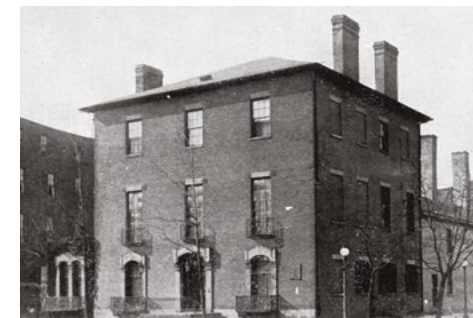
[2] (a) Decatur House in Washington, DC, was designed by William Henry Latrobe and constructed in 1816. (b) In the late-19th century, the façade was “modernized” by removing the limestone lintels on the first floor and replacing them with decorative sandstone lintels in the style of the period. (c) In the mid-20th century, the house was brought back to its original appearance based on historic documentation. Photos: The White House Historical Association and Decatur House, a National Trust Site.

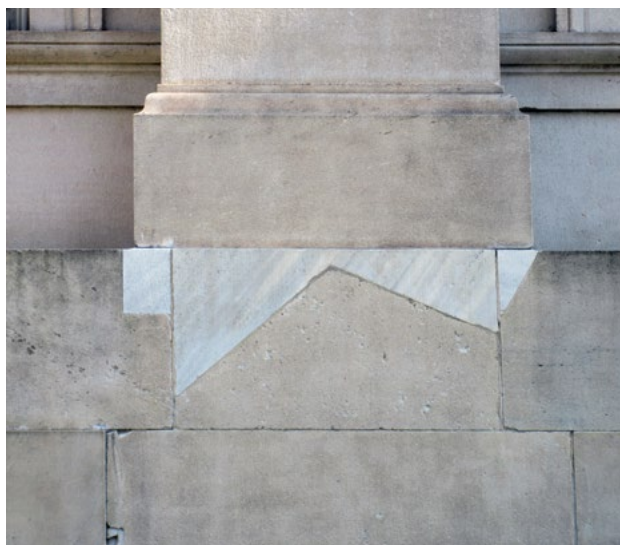
[3] **Not Recommended:** Although the Dutchman stone repair has been well executed, the replacement stone is not a good color match.

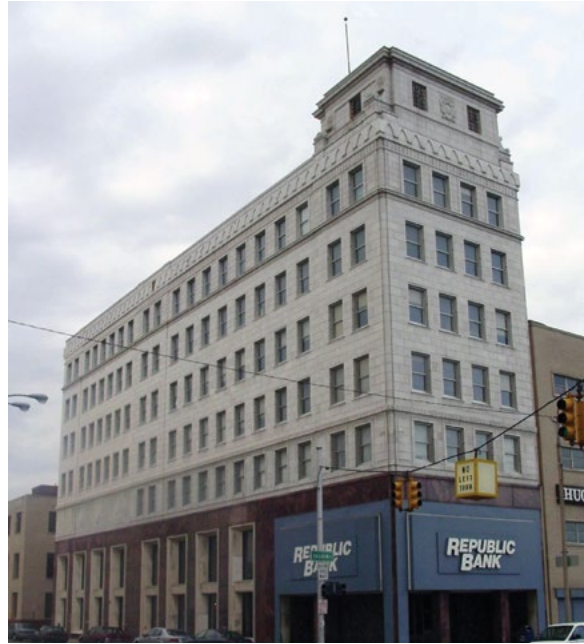
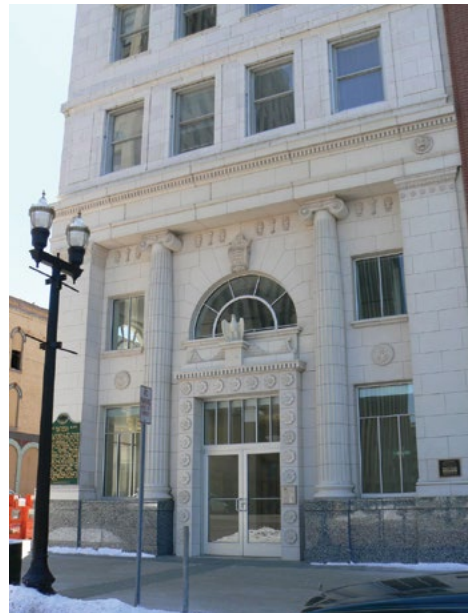
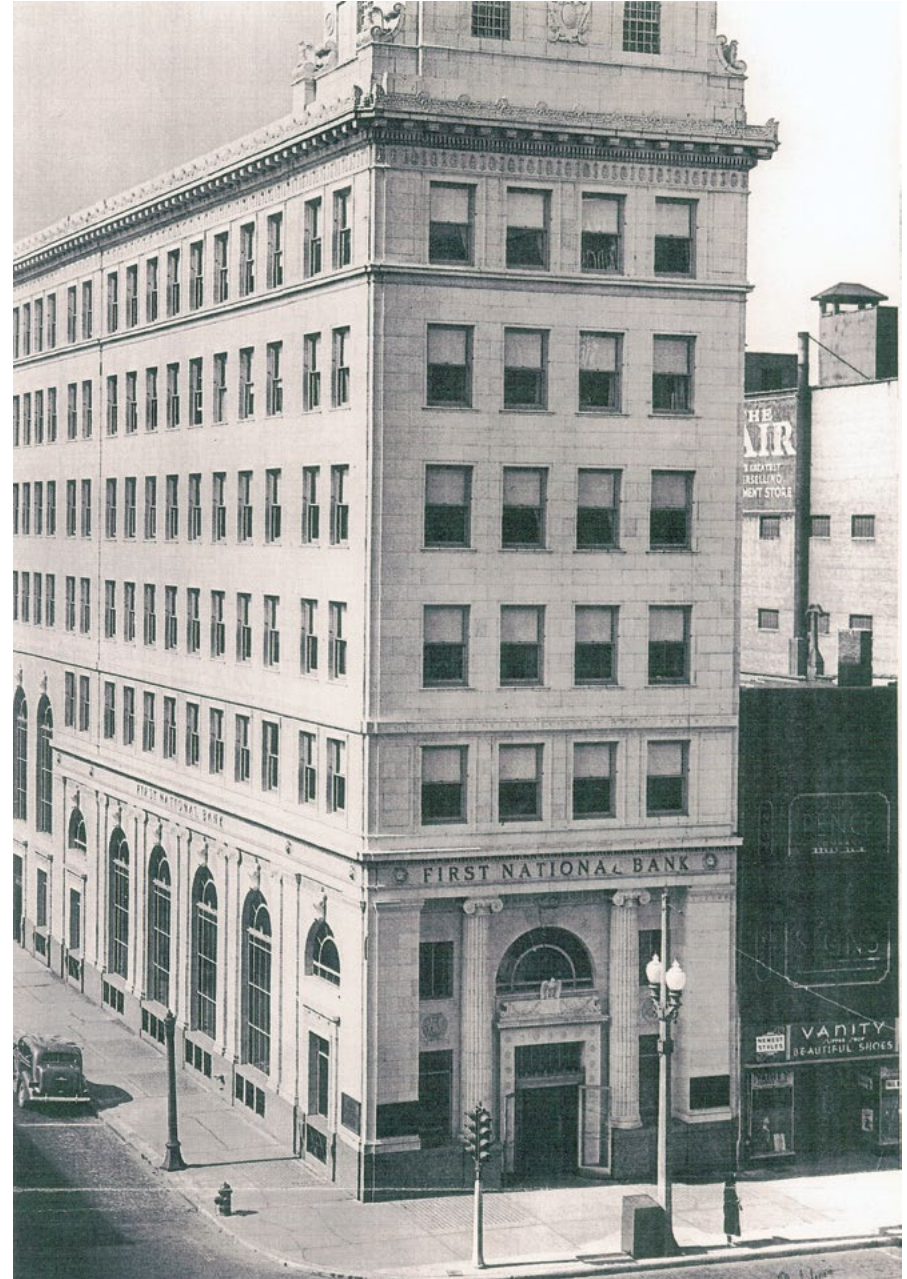
[4] (a) Over the years terra-cotta cladding had been replaced on the lower floors of this early-20th century bank building with a storefront and incompatible windows. (b) A 1936 photograph of the building provided the documentation to restore its historic appearance. (c) Glass fiber reinforced plastic (GFRP) was chosen as a substitute material, and samples were made in a variety of colors and textures to obtain the best match for the missing and damaged terra cotta. (d) This photo taken after restoration shows that the GFRP replacements successfully blend in with the original terra cotta. Photo (d): Blamonet at English Wikipedia.

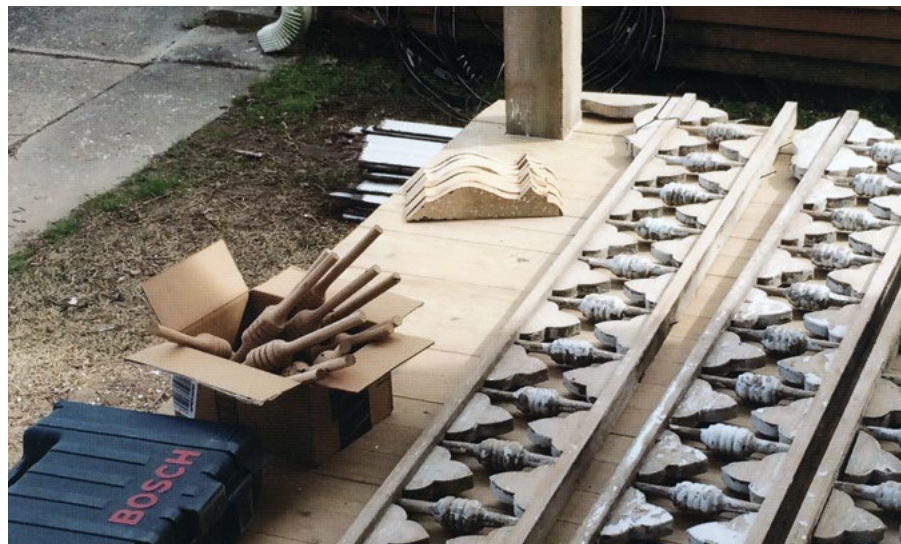
[5] New wood trim pieces were milled to match the few remaining historic features to replace those that were missing.

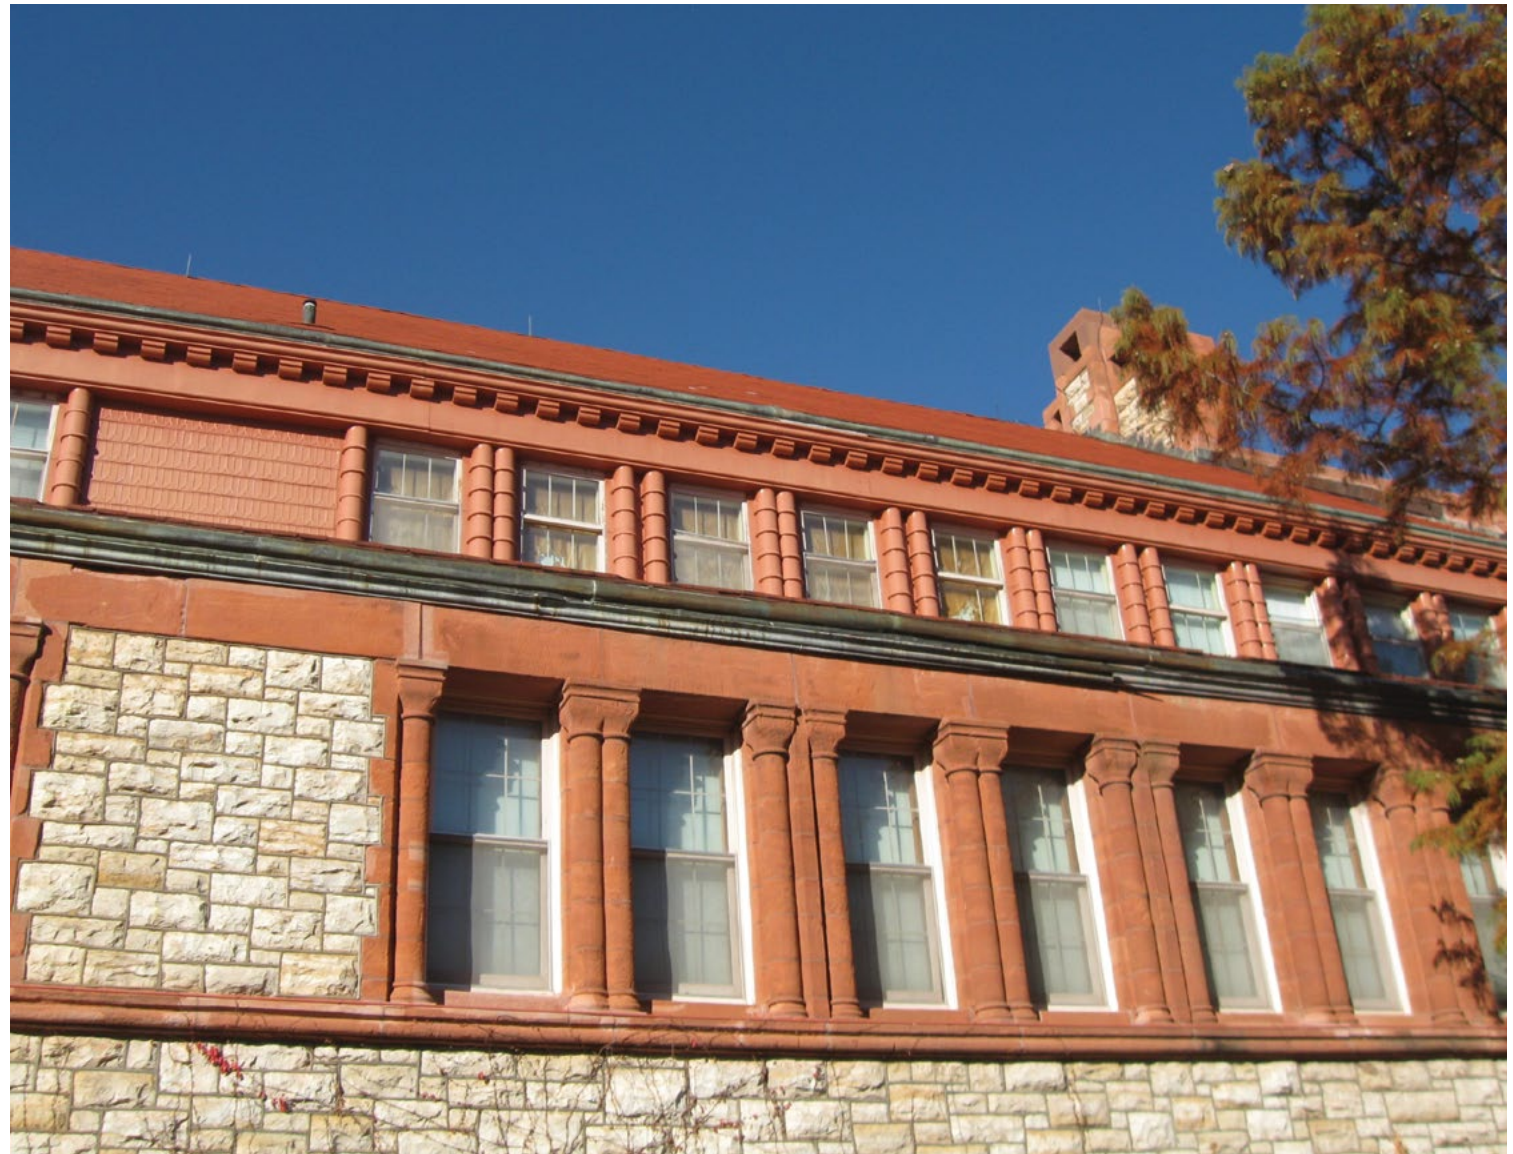
[6] Preliminary work before starting restoration revealed that the columns and the decorative shingles ornamenting the top floor of this historic building were fabricated of metal to imitate the red sandstone used elsewhere on the building.

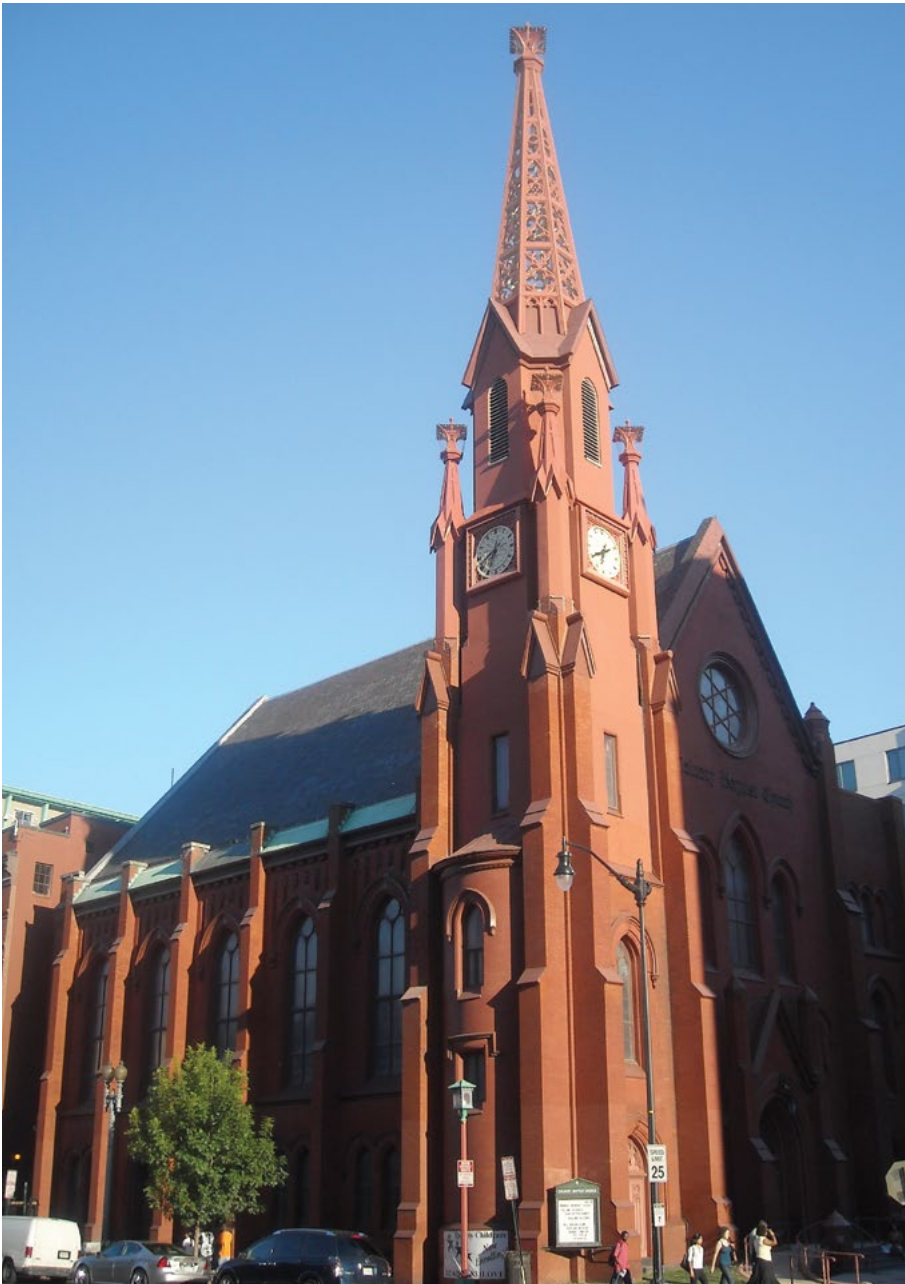
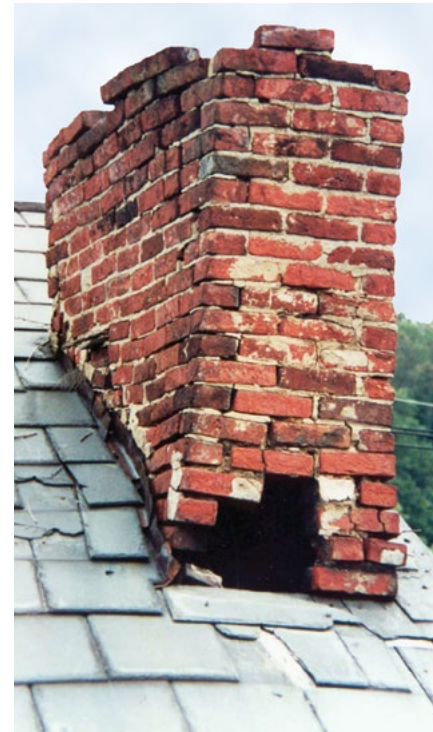
[7 a-b] This crumbling chimney was restored to its historic appearance using matching bricks.

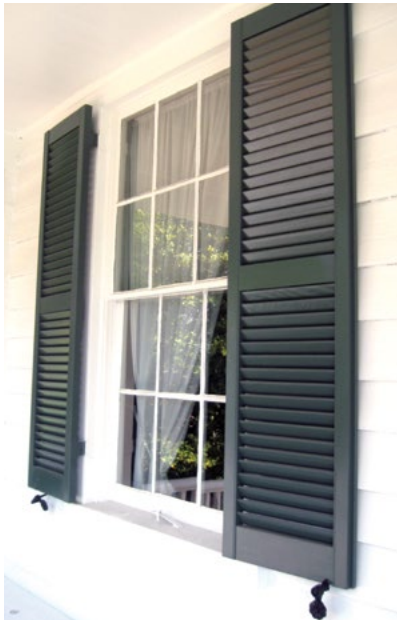
[9] Historic window and shutter hardware such as that shown here should be retained and repaired in a restoration project.

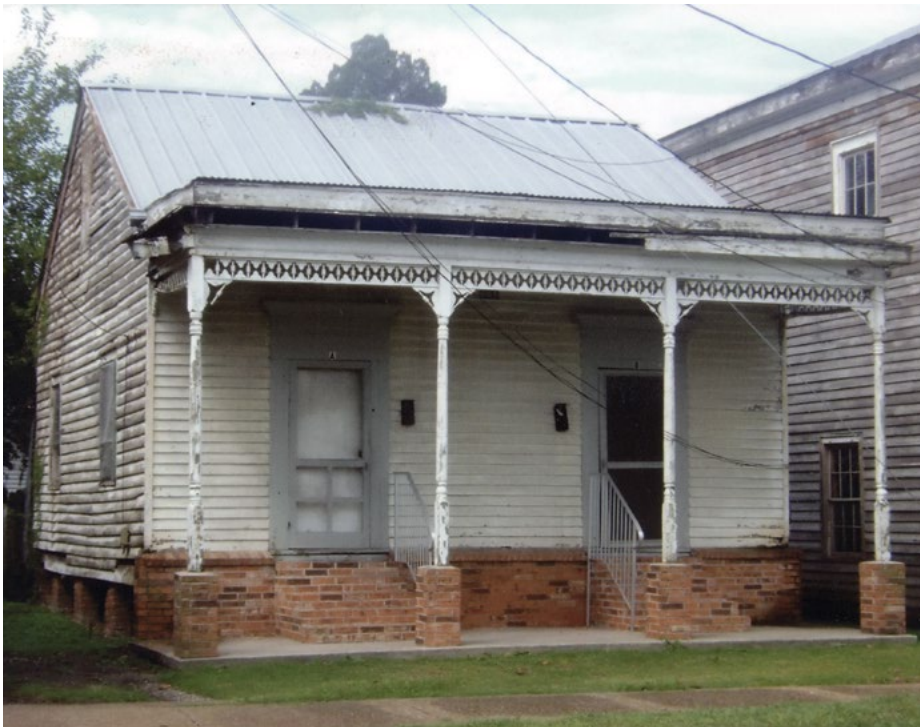
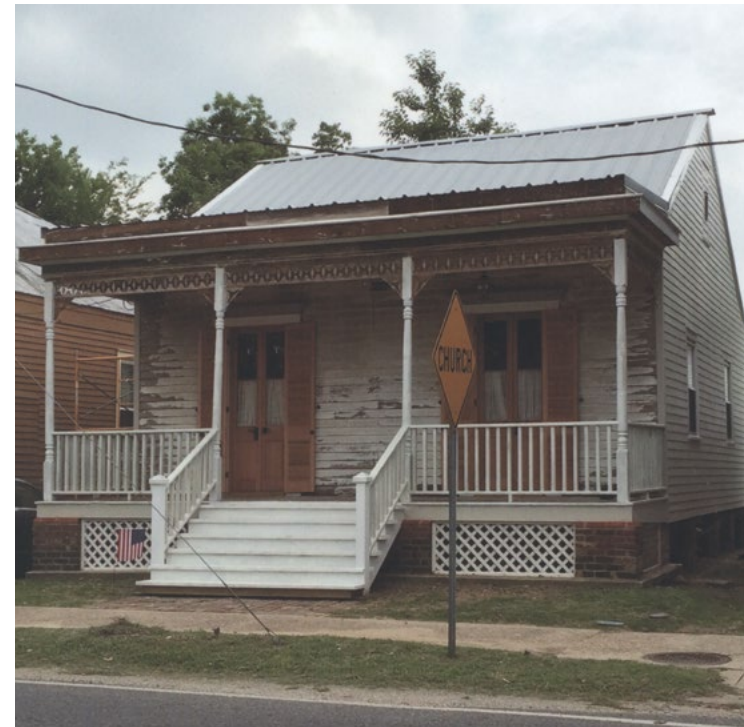
[10] (a) The entrance of this house had been altered over the years, including removal of the porch floor and steps. (b) This photograph shows the house after the porch and steps were restored to their historic appearance.

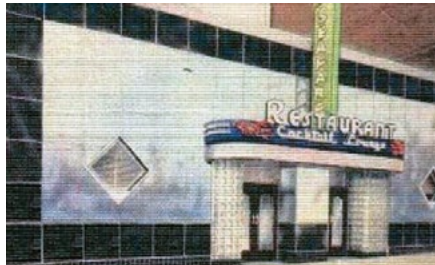
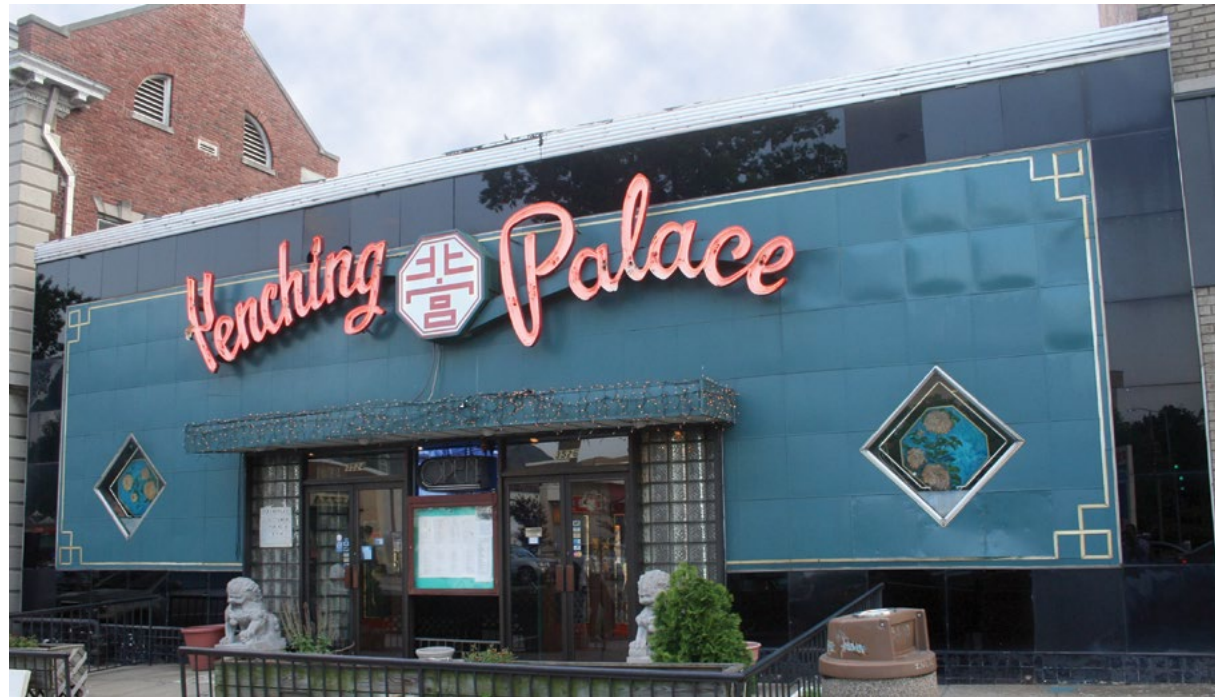
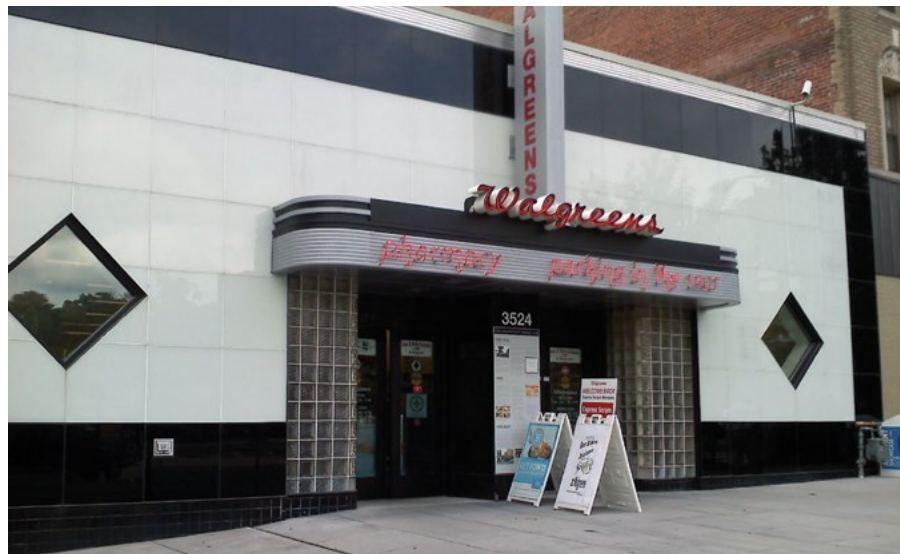
[11] (a) Some of the materials on the front of this historic building had been previously replaced, but the façade retained its essential distinctive features and design. (b) A vintage postcard of the building (far left) provided sufficient documentation to restore the façade to its historic 1945 appearance, using spandrel glass as a replacement for the original Carrara glass (c). Photo (b): Courtesy Kelsey & Associates.

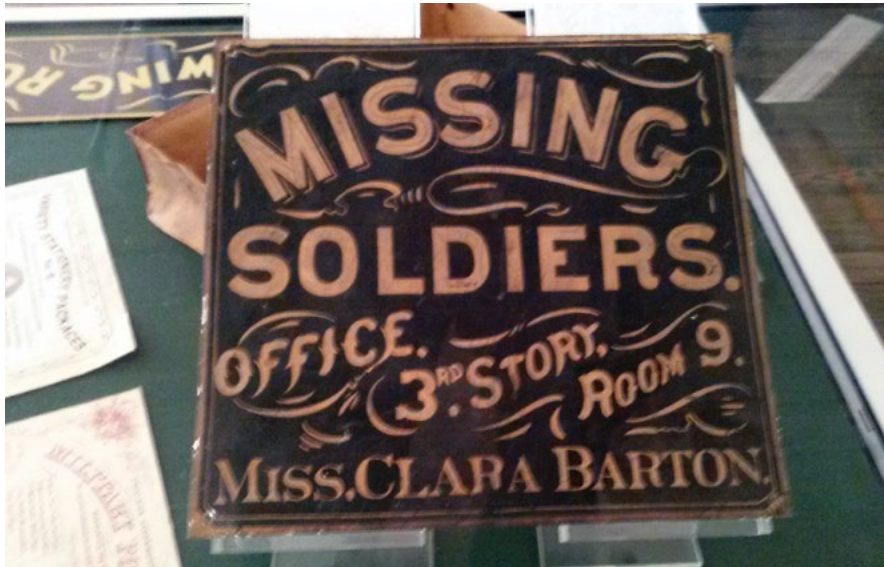
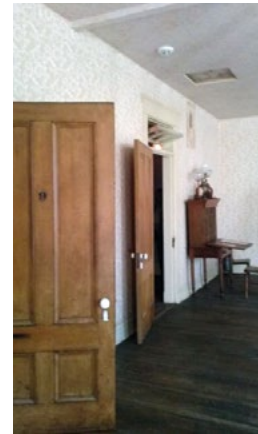
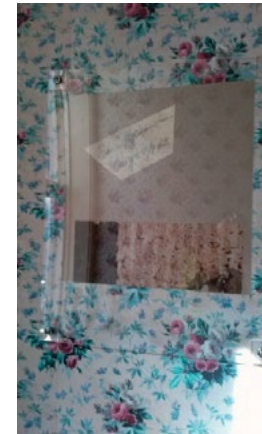
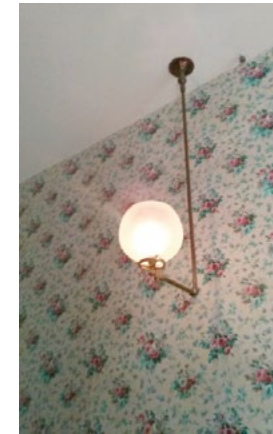
[13] (a) In the 1990s the Missing Soldier's Office—established by Clara Barton at the end of the Civil War—was discovered still extant on the third floor of a building in Washington, DC, that was slated for demolition. The office was restored to its historic appearance using physical and documentary evidence. The original numeral '9' is still on the door to the office, and wall paper was reproduced from scraps found on the walls (b-d).

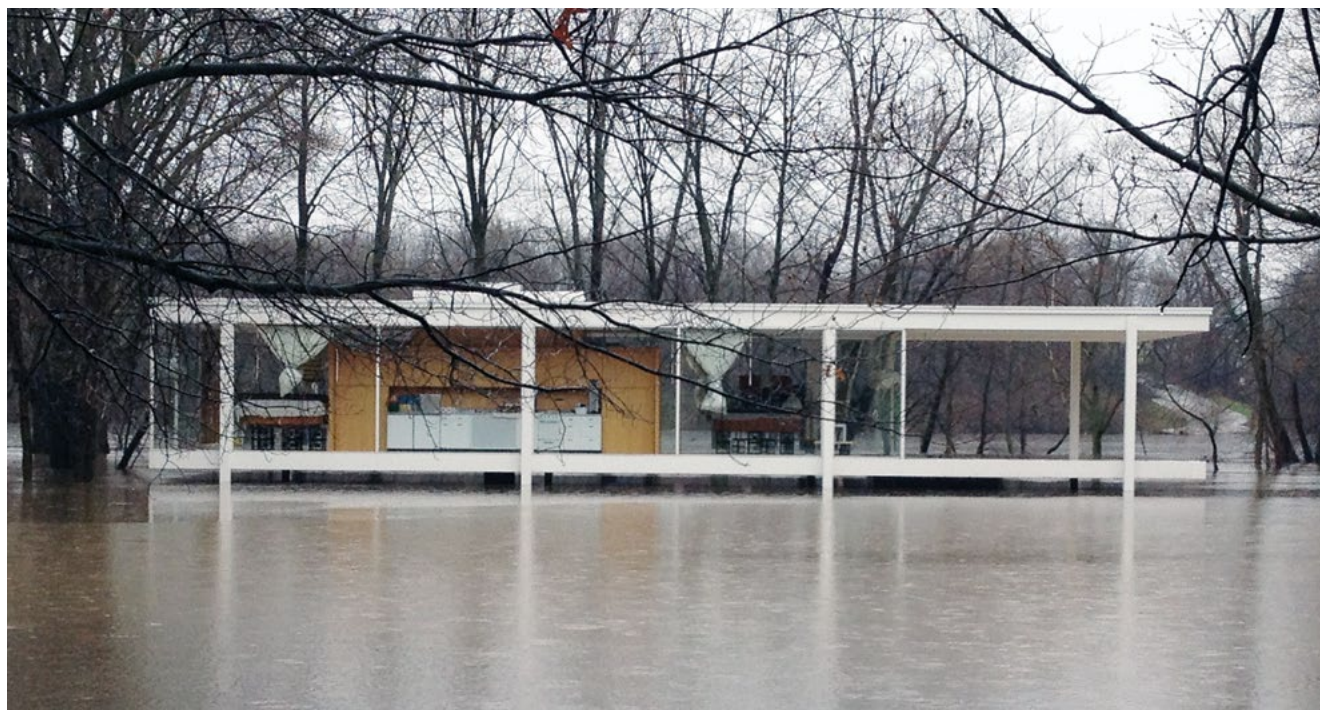
[19] The 1951 Mies van der Rohe-designed Farnsworth House, Plano, IL, was built close to the Fox River, which is increasingly prone to floods. To preserve the house in its original location, historic preservation architects and engineers continue to explore ways to protect it from the flooding, including a possible system that would lift the house above the flood waters and lower it back to the ground. Photo: Courtesy Farnsworth, A Site of the National Trust for Historic Preservation.

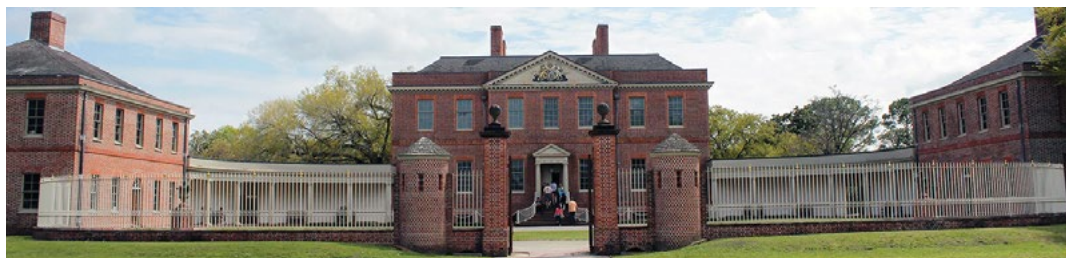
[1 a-b] Tyron Palace, New Bern, NC, was designed by John Hawks in 1767 for Governor William Tyron. It was completed in 1770, but destroyed by fire in 1798. The palace was reconstructed in 1959 based on the original plans, and on its original foundation, which was found 5 feet below the street, with the help of the 1767 drawing. Photo: Courtesy Tyron Palace, New Bern, NC. Drawing: Courtesy of the State Archives of North Carolina.

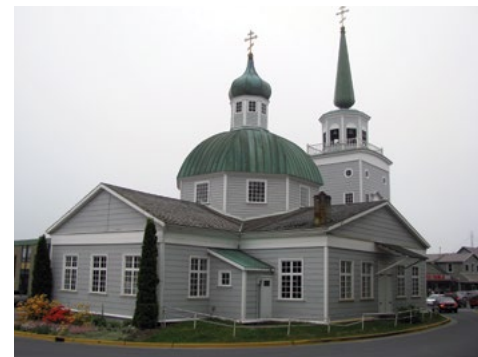
[3] The Cathedral of Saint Michael the Archangel, built in the early 1840s in Sitka, AK, was devastated by fire in 1966. It was reconstructed using measured drawings done in 1961 by the Historic American Buildings Survey (HABS). While the original cathedral was built of logs covered on the exterior with wood siding, its replacement is a fire-resistant structure with concrete and steel walls that replicates the historic building's appearance. Photo: Barek at Wikimedia Commons.

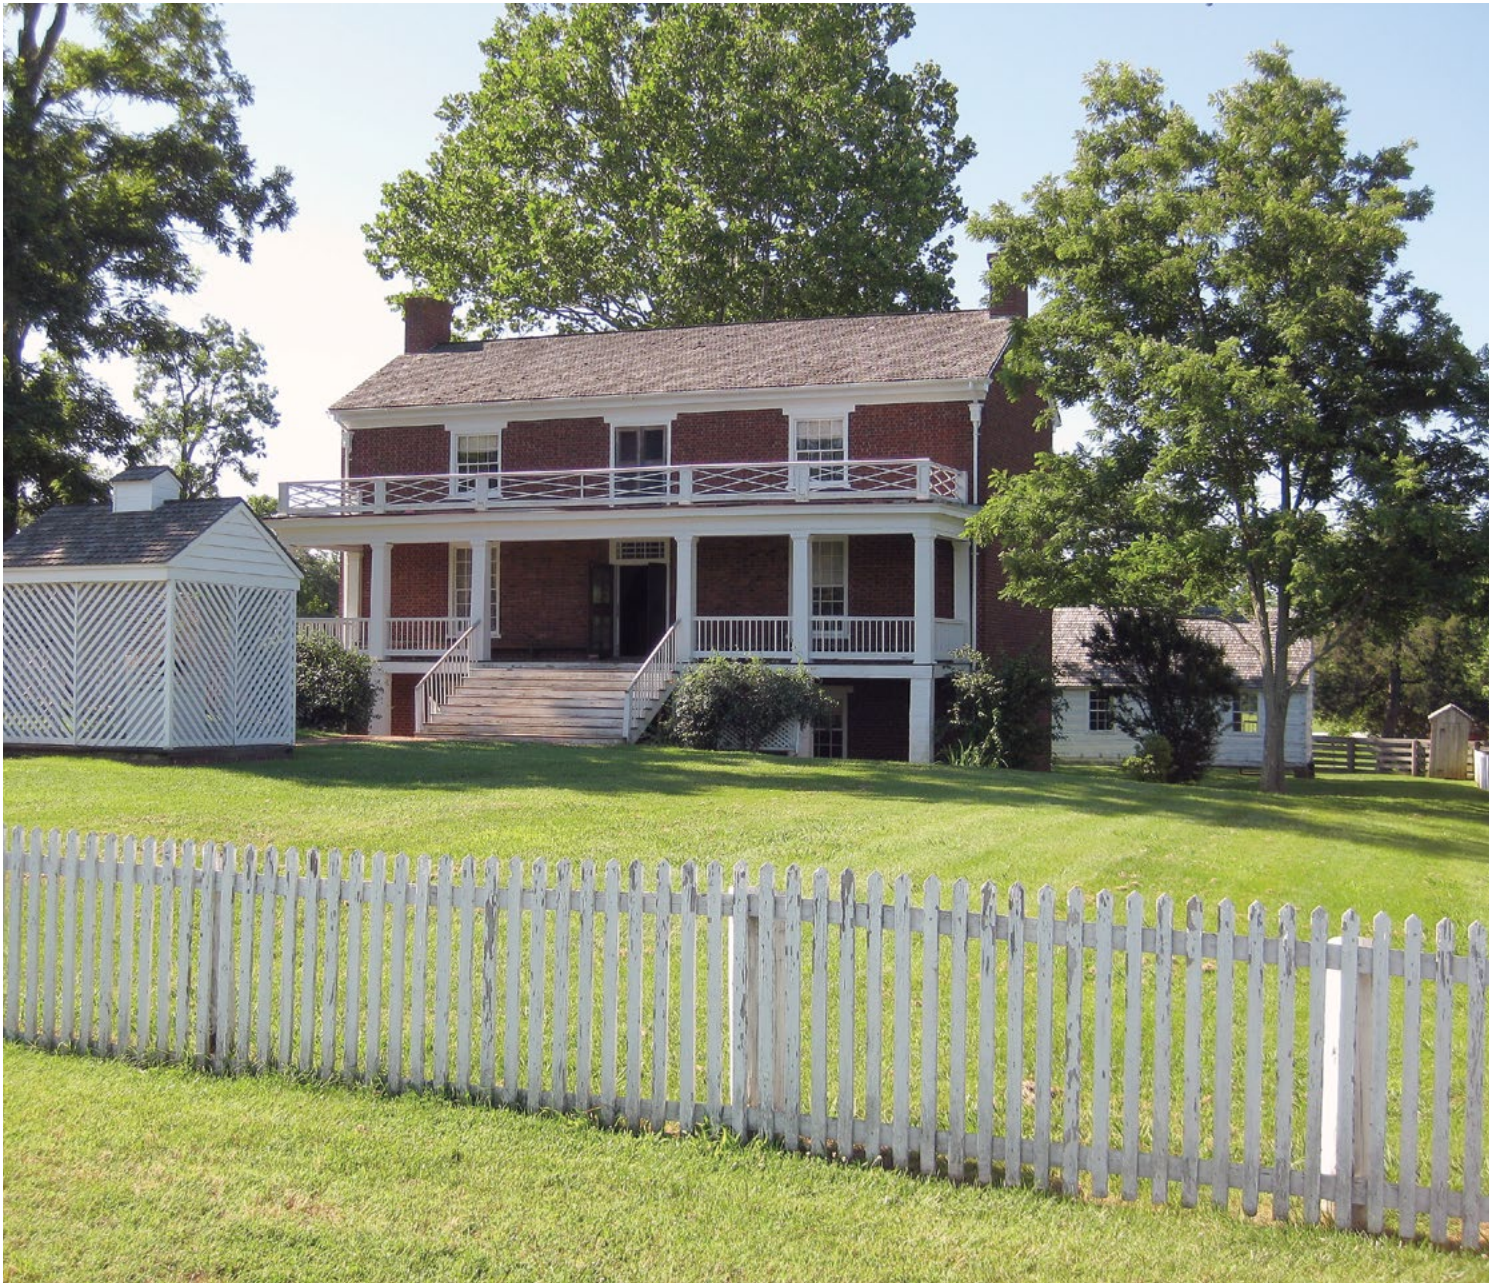
[4] The McLean House, where Robert E. Lee surrendered to Ulysses S. Grant, is located on the site of the battlefield—now part of Appomattox Courthouse National Historical Monument (VA). Several years after the end of the Civil War, measured drawings were made of the house before it was dismantled to be moved to Washington, DC, where it was to be reconstructed as a tourist attraction. This scheme never came to fruition, and the dismantled pieces gradually disappeared. The house was accurately reconstructed in 1949 on the original site based on the measured drawings.

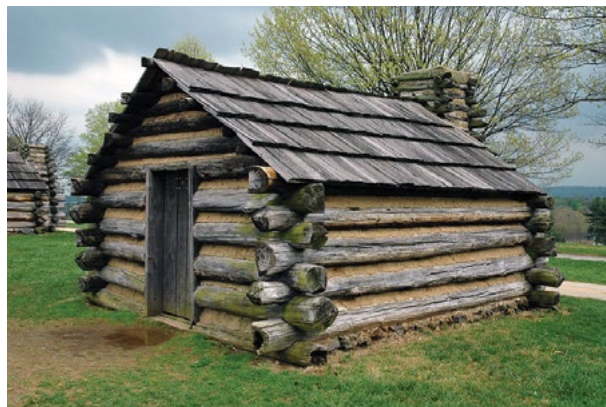
[7] The Muhlenberg Brigade Huts are reconstructions of nine log huts erected in 1777 at Valley Forge during the Revolutionary War. They have been reconstructed on the historic road with logs cut with modern power tools and finished with cement, unlike the original logs which were hand hewn and finished with traditional chinking. *Photo: Rdsmith4 at Wikimedia Commons.*

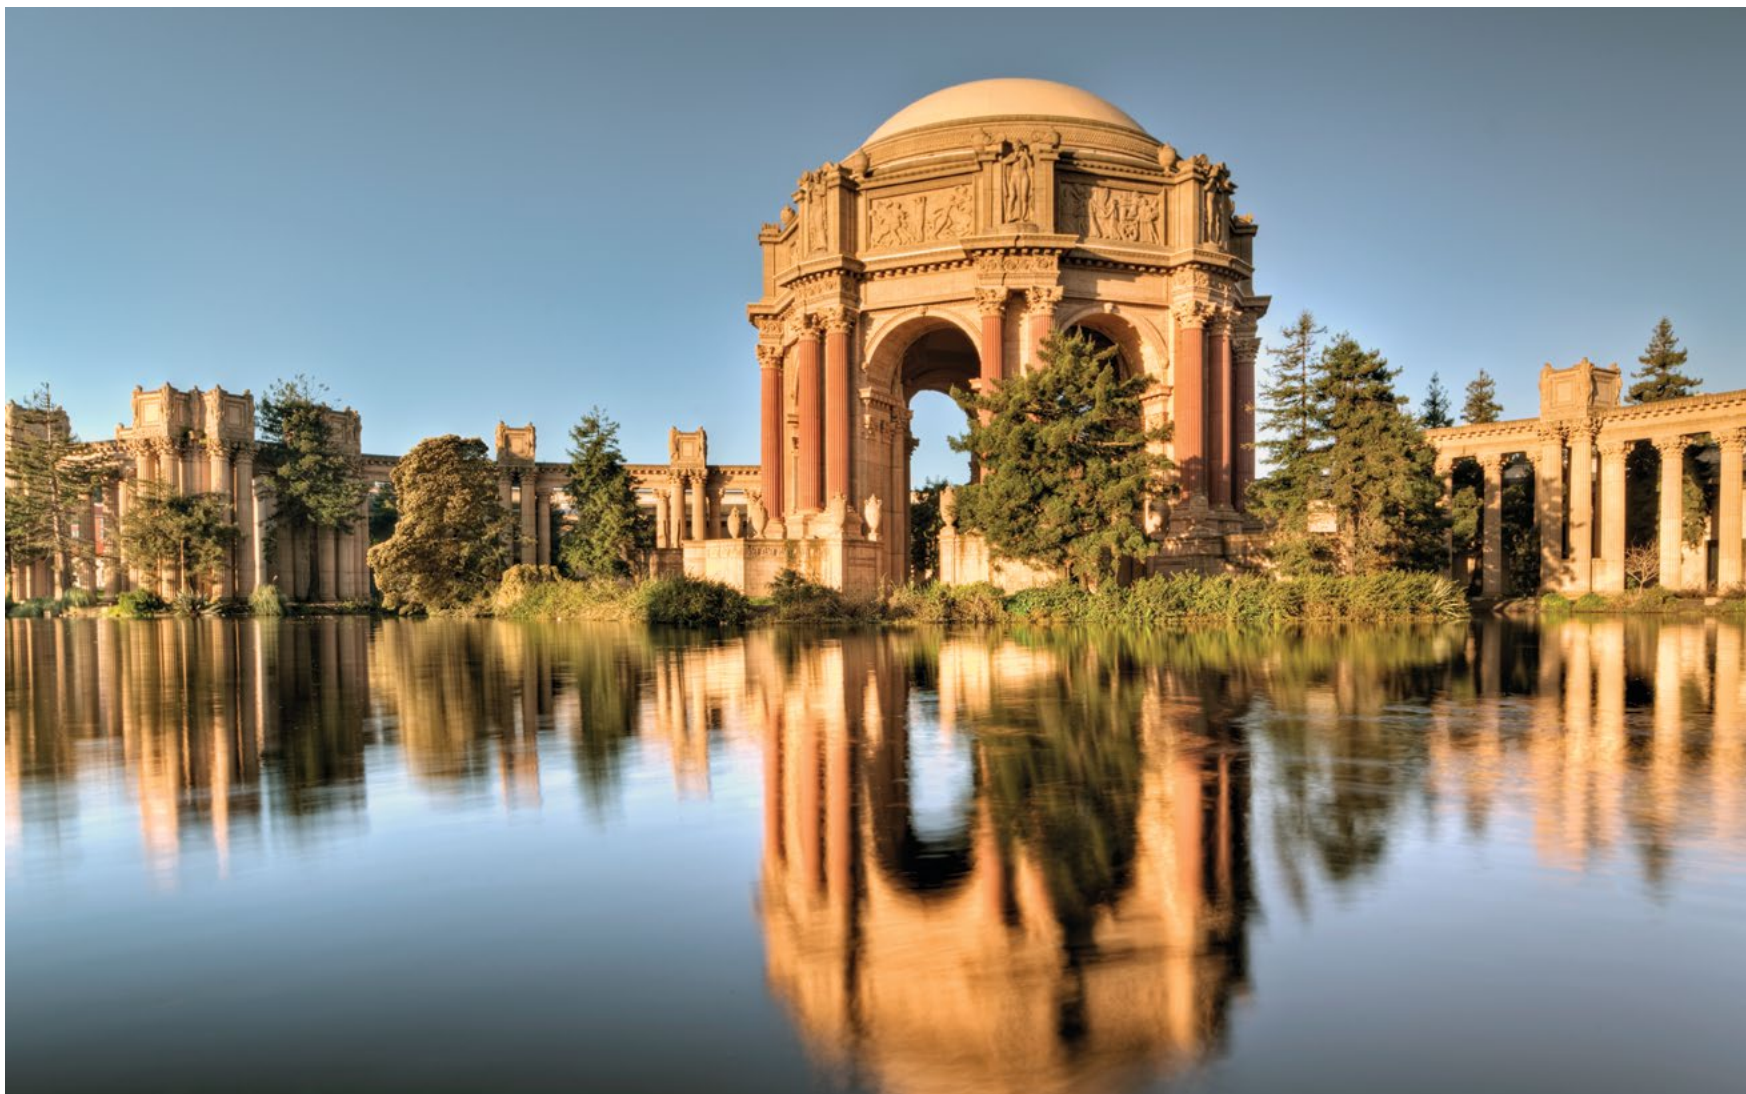
[8] The Palace of Fine Arts was designed by Bernard Maybeck and built for the 1915 Panama-Pacific Exposition in San Francisco. The pavilion was intended to be temporary and, although it had a steel structure, the exterior was finished only with stucco, an impermanent material composed of plaster and fiber. The building was not torn down after the exposition, and it eventually fell into ruin. In 1964, all but the steel structure was demolished, and the building was reconstructed with lightweight poured-in-place concrete. *Photo: KevinIcole at Wikimedia Commons.*
