OLD EXECUTIVE OFFICE BUILDING

BUILDING CONDITION REPORT

PREPARED FOR
THE GENERAL SERVICES ADMINISTRATION
NATIONAL CAPITOL REGION
WASHINGTON, D.C.

JUNE 6, 1990

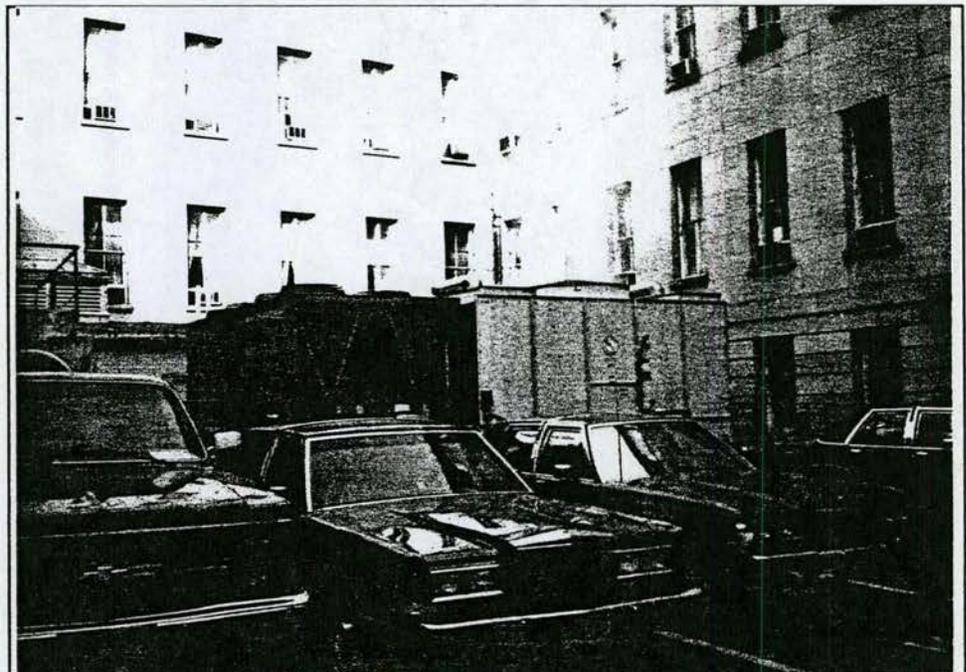
Photo 8

View to north end of South Court showing cooling towers for various areas within the White House Complex.

ANTICIPATED LIFE EXPECTANCY	Not applicable.
RECOMMENDED ACTION	Develop comprehensive plans for the reclaiming of the courtyards. Establish parking criteria to minimize the number of automobiles. Proceed with development of new mechanical equipment rooms or structures to allow removal of existing mechanical equipment from the south courtyard.
PRIORITY	
COST ESTIAMTE	To be provided in the Preliminary BER.
REFERENCES	Photo No. 8.

PRIORITY	
COST ESTIMATE	To be provided in the Preliminary BER.
REFERENCES	Photo No. 8.

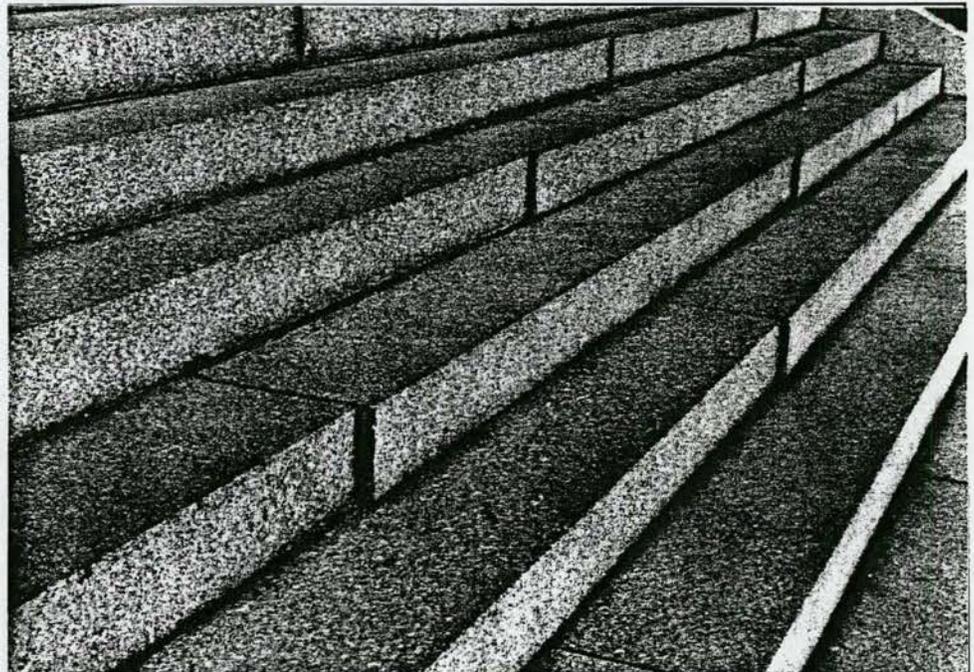
Photo 34

Note open joints and displacement at granite steps.

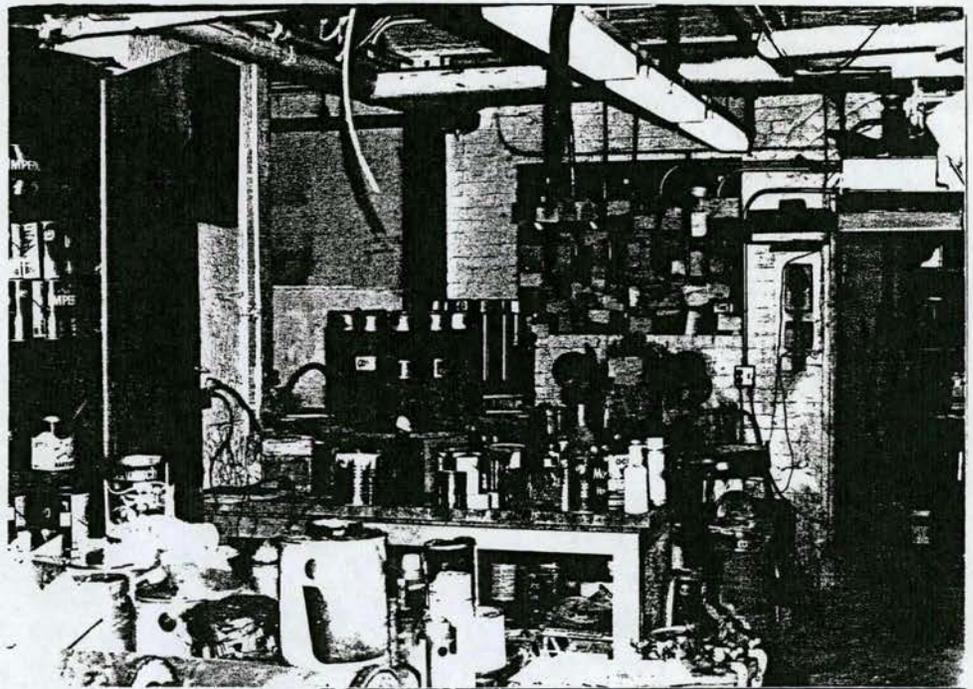
REFERENCES NFPA 33
Photo No. 47.

Photo 47 Existing conditions in Paint Shop.
